# ReBuild

Vol. 3 No. 4 (Oct-Dec 2009)

## Preservation, Rehabilitation and Restoration of Historic Structures

### A Case Study Of Lord Jagannath Temple at Puri, Orissa

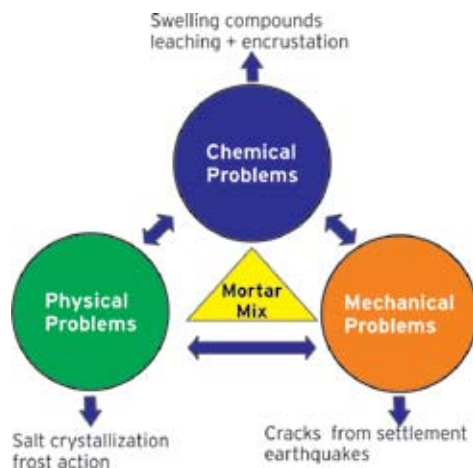
Fig: 1 Degradation phenomena

The damage cases explaining phenomena such as salt damages due to presence of salt in material or from other sources, Moisture in salt solution, it's drying & moves towards drying face, surper-saturation & crystallization / dissolution cycles, lime leaching, mechanical problems such as cracks from settlement, earthquakes etc., physical & chemical problems, and detachment through plant grow & freeze thaw cycling were elaborated. (Figure 1)

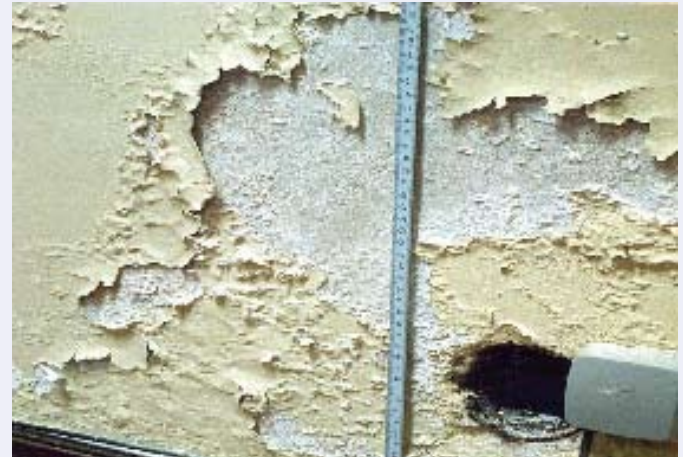
Fig: 2 Salt damage of weak pointing material

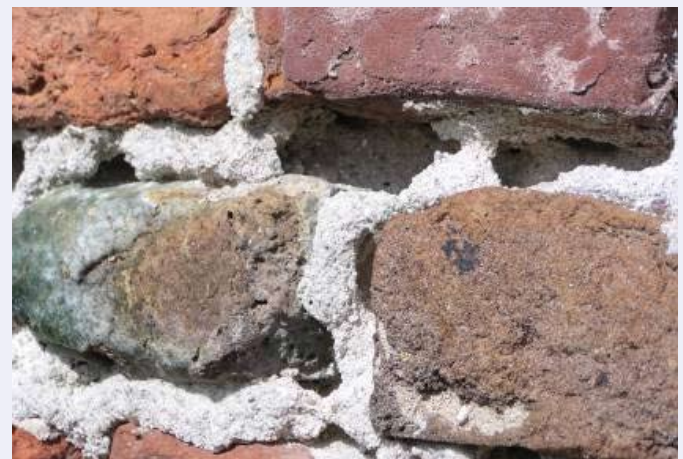
Fig: 3 Damage through salt Crystallization

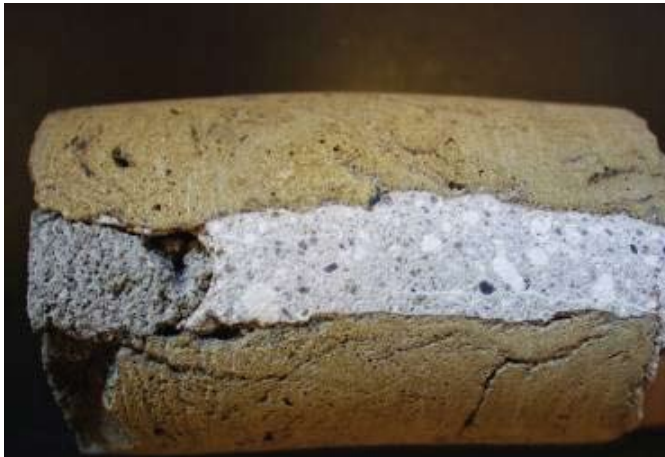
Fig: 4 Dense repointing leading to frost damage

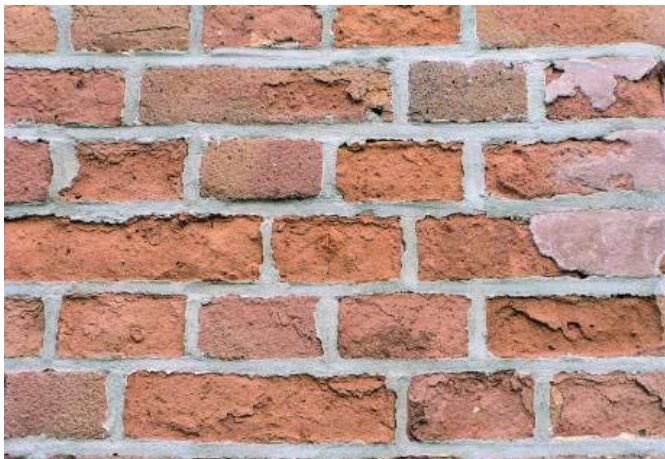
Fig: 5 Subflorescence caused by water repellents

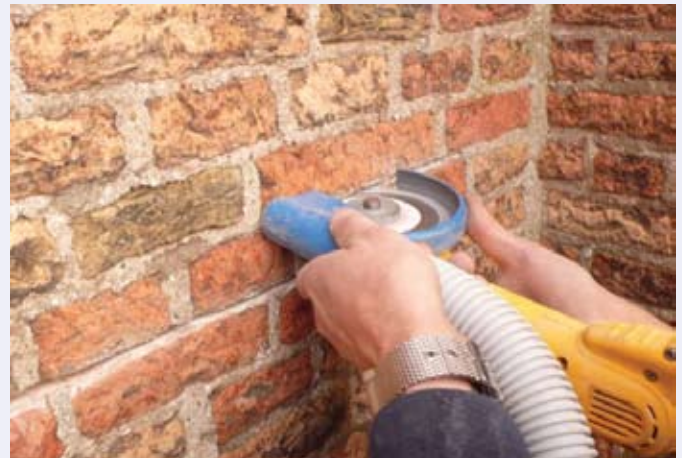
Fig: 6 Raking out of joints mechanically

Apart from material characterization the execution of the work is an essential element of the soundness of proposed repair. The repointing practices such as raking (manual & machine) expansion groove, mortar joint section repointing etc. has been highlighted in figures 6 and 7. For this a clear rectangular space instead of a V-shaped joint must be raked in the mortar joint of width not less than twice the joint thickness for placing the repointing mortar.

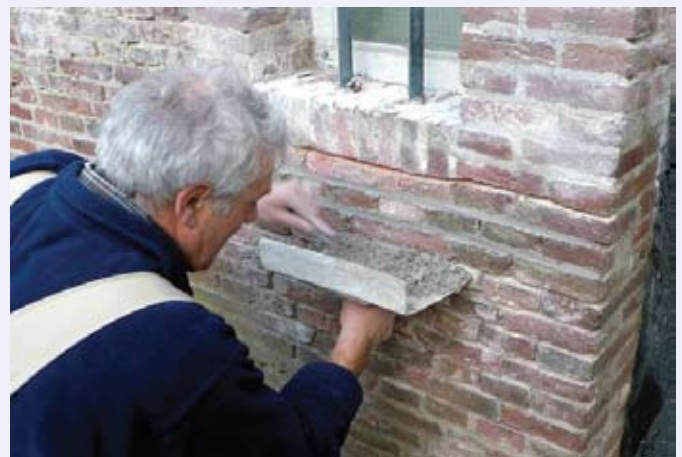
Fig: 7 Repointing

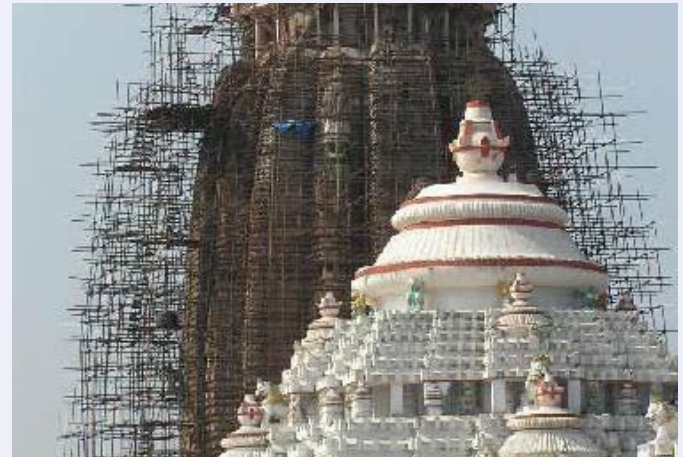
Fig: 2 Renovation of outer face

- Tubular scaffolding were made for treatment of outer faces as shown in (Figure 2).

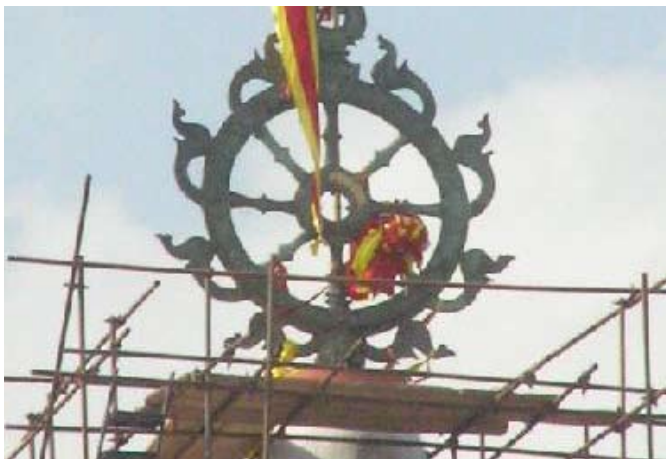
Fig 3: Treatment being given at kalash

The treatment to the kalash shown in (Figure 3) and temple after complete renovation shown in (Figure 4).

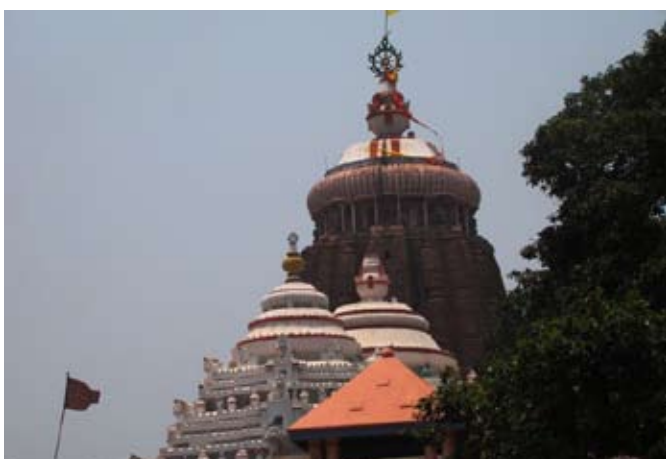
Fig 4: Temple after renovation

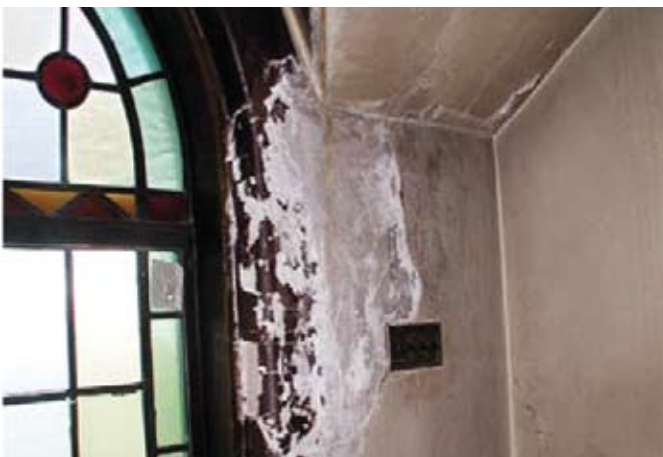
Fig 2: Distress in plastering

Much more of a concern than the cosmetic problems, however, was the fact that the mortar in the brick exterior was beginning to erode and water had begun leaking into the bell tower and the south-east chimney. Water had also begun entering the bell tower's louvers during heavy rains.

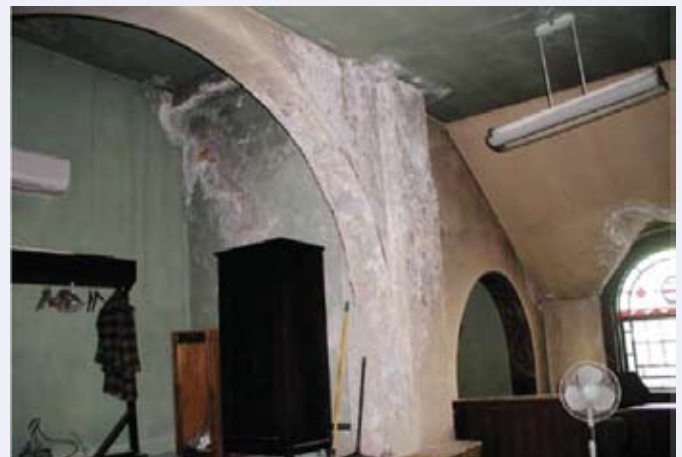
Water that made its way into the bell tower would pool on the third level's concrete floor and then seep through to the second level and into the choir area of the church below. The plaster on the ceilings and walls of the church was being destroyed (Figures 2 & 3) by the water damage. But most distressing was the fact that the many historic religious paintings were being damaged and destroyed (Figure 4).

Fig 3: Distress in internal walls

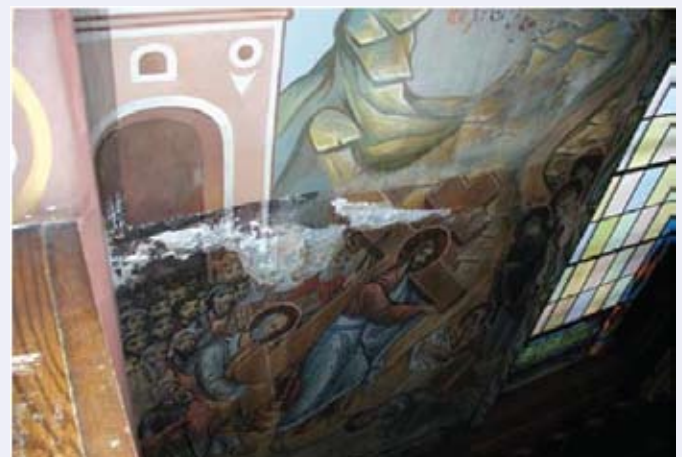
Fig 4: Damages in wall paintings

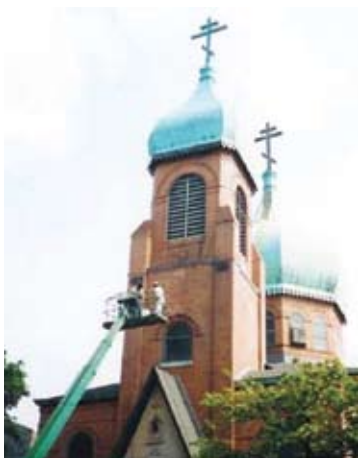
Fig 5: Cementitious crystalline waterproofing on external surfaces

When the exterior work was done, the church's interior leakage problems were addressed. On the third (top) level of the bell tower, where a sloped concrete floor had recently been created to direct any incoming water to an external drain, a local contractor applied a cementitious crystalline water-proofing product to fortify the concrete and stop water from leaking through to the second level of the tower.

The crystalline waterproofing product reacts with concrete to form crystals that migrate into the concrete to block pores, voids, and tiny cracks that would allow water penetration. Over the life of the structure, these crystals will continue to react with incoming water to self-seal small cracks, providing long-lasting protection against leakage. For extra reassurance, the church opted for a product with a 10-year guarantee.
