## Concrete Slab Repair:

### Getting Flat is One Thing, Staying Flat is Another!

by Scott M. Tarr, Peter A. Craig, and Howard M. Kanare  
(Extracted from Concrete Repair Bulletin January/February 2006)

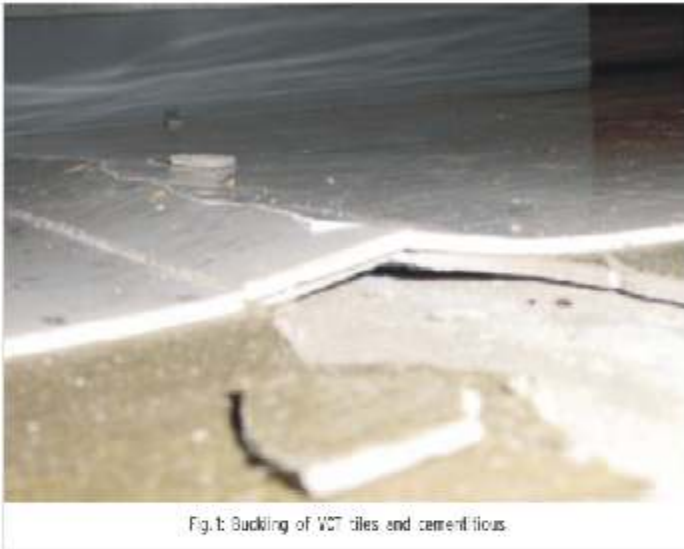
Fig. 1: Buckling of VCT tiles and cementitious

of the flooring system, which can create a tripping hazard such a that shown in Fig. 1. Where floor covering systems buckle along joints and cracks, the delaminations are commonly referred to as mole holes or mole trails.

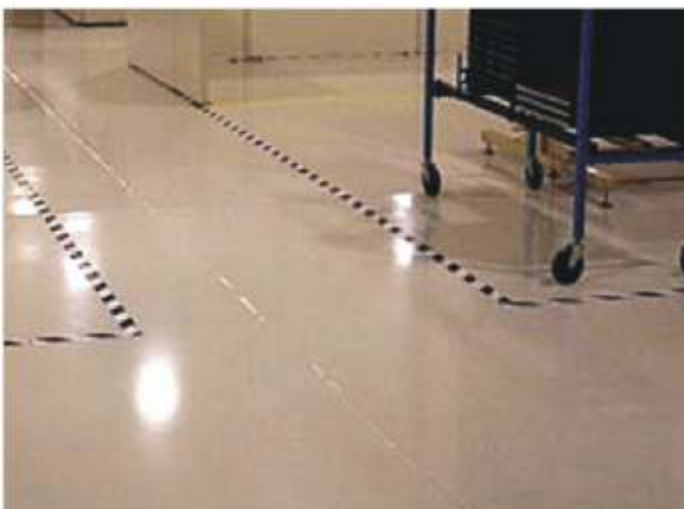
Another condition that can be the result of warping relaxation is the extrusion of filler or leveling material from joints and cracks as shown in Fig. 2, 3 and 4. When slab edges warp upward, joints and cracks become v-shaped in profile (wider at the top surface than at the bottom). Material used to fill in these joints/cracks can be extruded out when the slab returns to its original shape and the joints/cracks close. Yet another form of distress caused by warping reversal is shown in Fig. 5. Often, isolation blockouts around columns and other through-slab structural components are in-filled well after the slab is placed.

Fig. 2: Extrusion of semi-rigid joint filler due to reverse warping (photo courtesy of Herman Prozel)

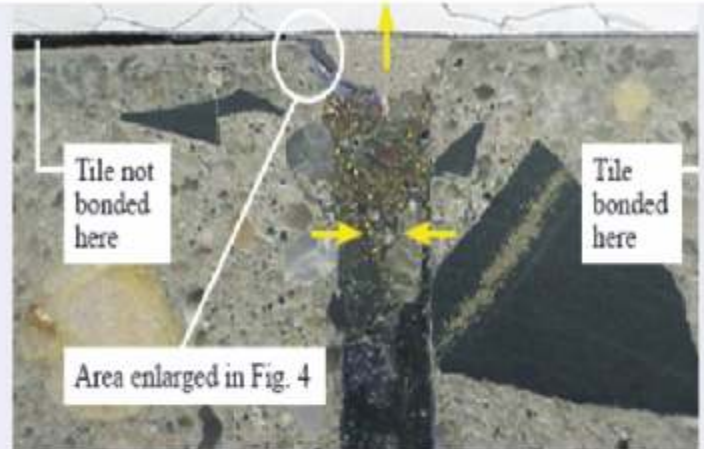
Fig. 3: Lapped cross-section of concrete core at sawcut joint showing patching compound thrust upward. Displacement of patching compound (arrow pointing upward) is caused by narrowing of joint (arrows) as the concrete slab relaxes from its warped posture

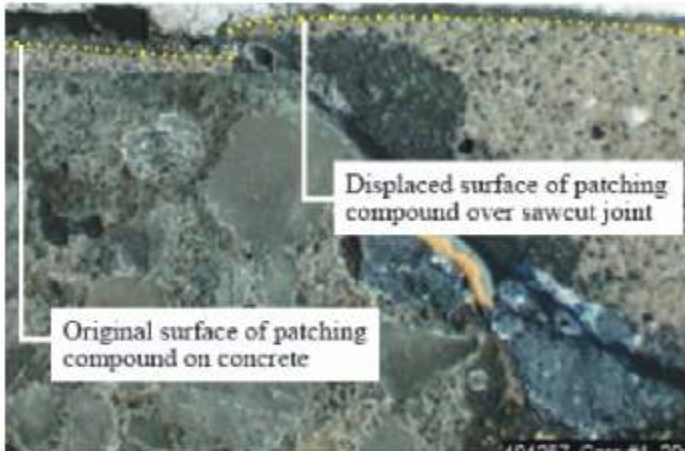
Fig. 4: Photomicrograph in reflected light showing details of patching compound movement upward. Dotted line indicated original surface and displaced surface due to movement. The black gap at top left is the space created when tile was pulled loose from the patching compound, forming a bubble

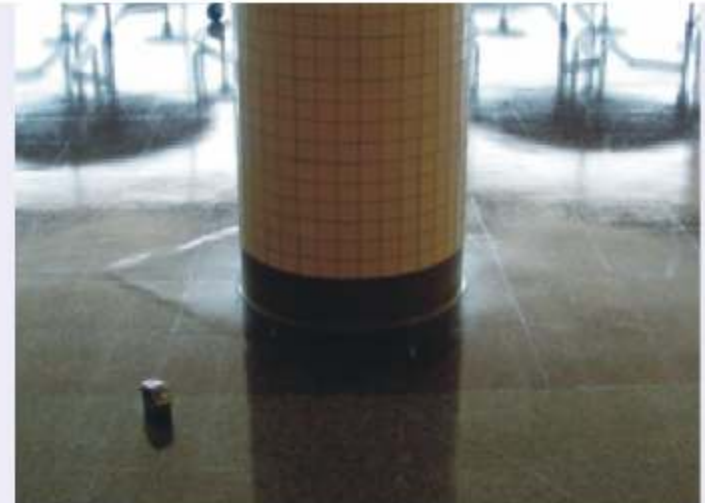
Depending on the length of time between slab placement and infilling, substantial edge warping can occur. The blockouts are screeded to the top of the surrounding slab surface at the time of filling. Therefore, significant grinding or leveling is not usually necessary for the flooring system in these locations. However, once the flooring system is installed and the moisture gradient equalizes, the warped edges of the surrounding slab relax back downward and the column infill appears to heave upward (Fig. 5).

Fig. 5: Reverse wrapping around isolated diamond blackout at column footing

Warping relaxation is not an isolated event. Conditions such as that shown in Fig. 5 can be found in many retail stores throughout the U.S. Most of the time, if the initial warping was only slight, the relaxation does not become an issue. Unless specifically designed to prevent warping, all slabs can be expected to warp somewhat. It is the magnitude of warping that potentially becomes an issue. As such, the shrinkage potential of the concrete mixture must be considered, regardless of the use of steel reinforcement. No climatic region of the U.S. is immune to excessive shrinkage and moisture-related problems. When upward slab warping has developed in a concrete slab to be covered or coated with a low permeance material, consideration should be given to filling the void beneath the slab edges before reprofiling the slab.

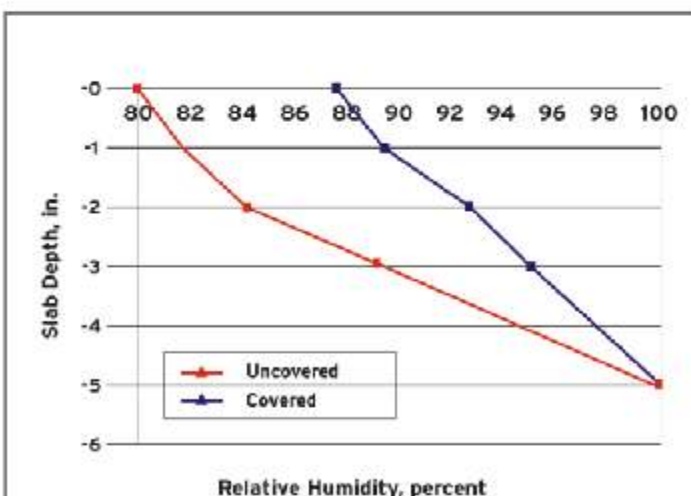
As only a portion of the facility was occupied, the authors were able to document the relative moisture gradients and warping magnitudes between adjacent covered and uncovered slabs. The measured moisture gradients are compared in Fig. 6, which plots the measured moisture gradient (horizontal axis) with slab depth (vertical axis). As shown, the relative humidity of the base material

Fig. 6: Relative moisture gradient between uncovered and covered portions of a slab

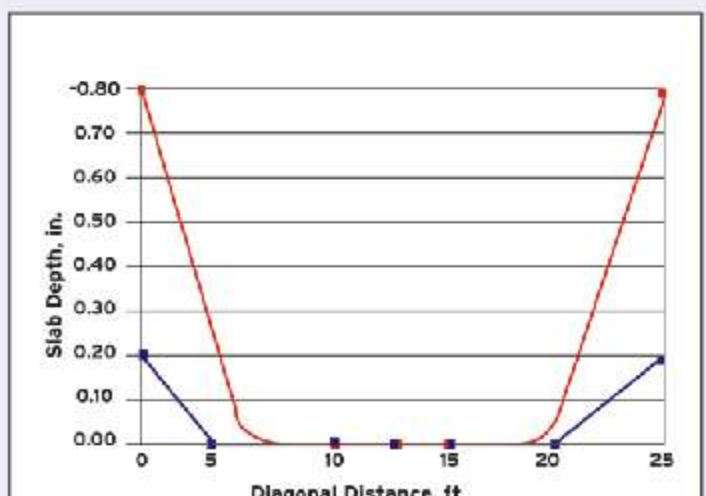
Fig. 7: Relative warping profile between uncovered and covered slab panels

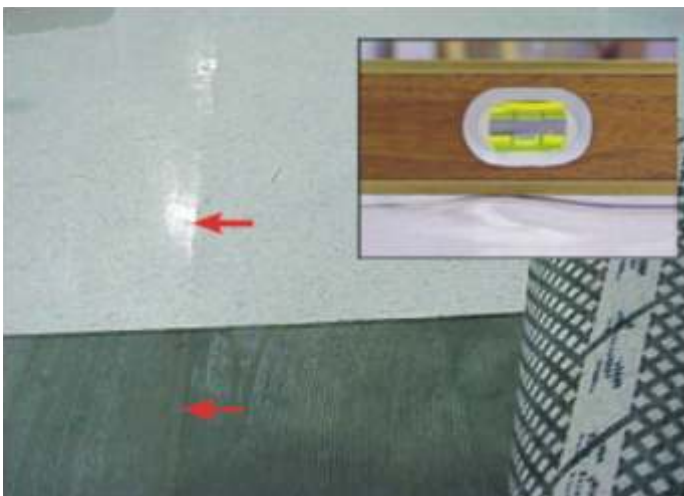
Fig. 8: Debonding and buckling of ESD tile flooring (note hump at arrow and insert)

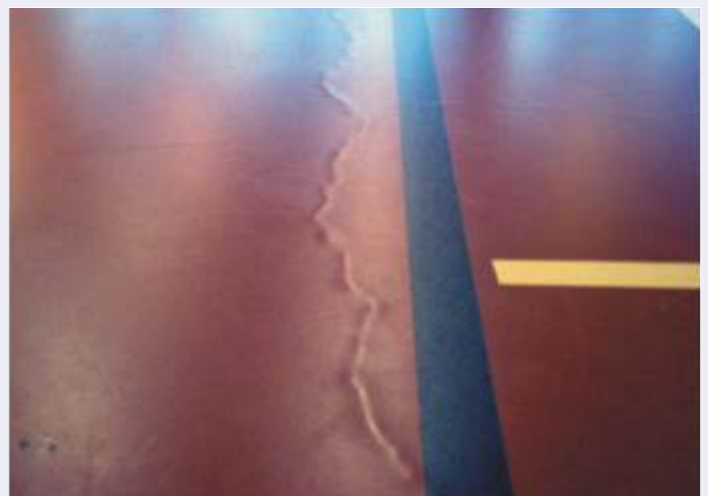
beneath the slab was nearly 100% for both the covered and uncovered portions of the slab. For the uncovered slab, however, the moisture gradient that developed was large (nearly 20% relative humidity) as the slab surface was trying to reach equilibrium with the ambient air. Once the slab was covered with the low permeance tile system, the moisture levels within the slab increased and the overall gradient was reduced by nearly half. As the moisture gradient was reduced, the warping magnitude decreased from as high as 0.80 in. (2.03 cm) to as little as 0.18 in. (0.46 cm), as shown in Fig. 7. As a result, the joints narrowed and the cementitious filler material was extruded (Fig. 3 and 4) and the ESD tiles buckled, as shown in Fig. 8. The same distress has been seen in other flooring systems such as poured polyurethane gymnasium floors, as shown in Fig. 9 (at a crack).

Fig. 9: Extrusion of crack filler beneath poured polyurethane gymnasium flooring
