## Structural Preservation of Monument

### A Case Study Of Lord Jagannath Temple at Puri, Orissa

By N.C. Pal

(Excerpt of proceedings of All India Seminar in Rehabilitation of Structures by Institution of Engineers, Bhubaneswar in 2003 from pages 8 to 22.)

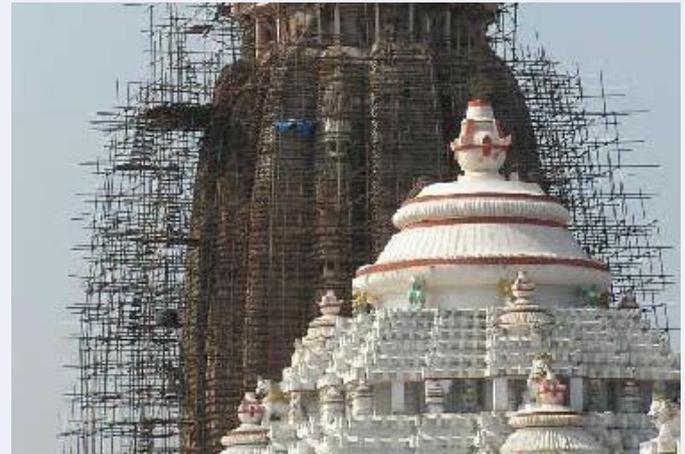
Fig: 2 Renovation of outer face

- Tubular scaffolding were made for treatment of outer faces as shown in (Figure 2).

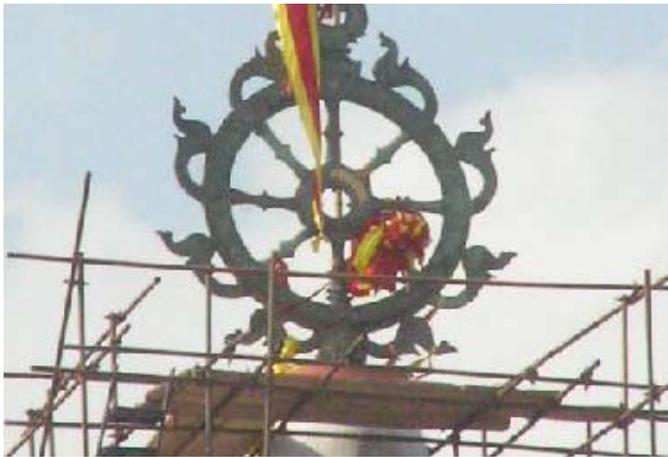
Fig 3: Treatment being given at kalash

The treatment to the kalash shown in (Figure 3) and temple after complete renovation shown in (Figure 4).

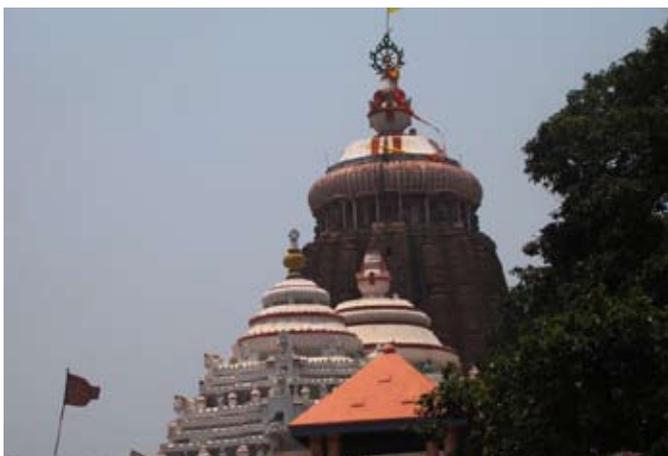
Fig 4: Temple after renovation
