Structural Strengthening of a Multiplex During Construction Stage in Chennai - A Case Study

[Edited from the archives of the case studies of CC Division of Pidilite Industries Limited, Mumbai]

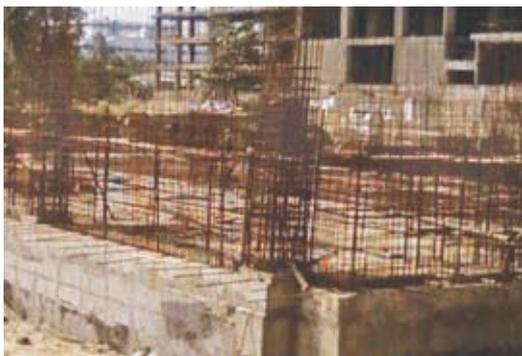
Fig. 2: Raft for structural strengthening

After the raft was drilled with holes to release the uplift pressure, the floor got completely flooded with water. There were structural cracks in retaining walls, RCC raft and bulging of columns of basement at many places. The structural consultant redesigned the raft foundation and advised to increase the raft size to 1200 mm from existing 450 mm of M40 grade concrete by anchoring the new concrete with old concrete with the help of bonding agent and anchor fix grouts for rebars.

3.3 Bonding of Old and New Concrete Layer of the Raft

The surface were rubbed and cleaned thoroughly. An epoxy based bonding agent was used to bond old with new concrete of the raft. It was a 2-component with base and hardener in proportion of 1 : 0.87. It had excellent bond strength and tensile strength was higher than its bond strength. The total surface area treated with epoxy bonding agent was around 20000 sq. ft. Since the area was quite large, the bonding agent was sprayed to the surface.

To have the structural integrity, anchor fix grouts were used by anchoring 12 mm, 16 mm and 25 mm diameter rebars of embedded length of 15 times the diameter of the bar (L_a) @ 500 mm c/c through out the raft slab as shear connectors. The holes were drilled of diameter 4 mm greater than the diameter of the rebar, cleaned and

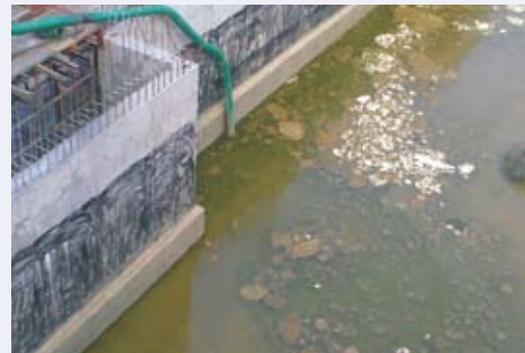
Fig. 3: De-watering by pumping

The flooded area was dewatered by pumping. A sump was created outside the raft from where pumping was done continuously (Fig. 3). Raft area was dried and all the locations of cracks were identified and marked for injection grouts.

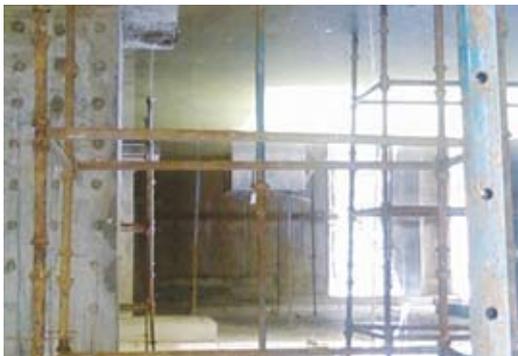
Fig. 4: Basement wall after PU injection

Certain place of the raft and wall of basement where the leakage was high, PU (Polyurethane) foam injection was used. PU resin was based on MDI (Methylene Diphenyl Isocyanate) polyurethane pre-polymer & accelerator. It had low viscosity, high penetration and very quick setting properties. It could form tough and flexible polyurethane rubber after complete chemical reaction. The various properties of two-component PU foam injection are given in Table. 2. Figure 4 shows the view of basement wall after PU injection was done.

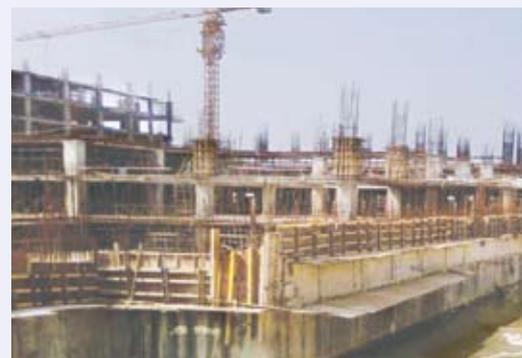
Fig. 5: Columns for strengthening

The sizes of existing columns (Fig. 5) are also proposed to be increased from 1000 mm x 1000 mm to the modified design size with self-compacting concrete.
