## Repair and Rehabilitation of Nehru Memorial College of K.V.G. Group of Institutions at Mangalore - A Case Study

[Extracted from paper published in conference proceedings of CEMCON-2011, organized by Indian Concrete Institute, Pune]

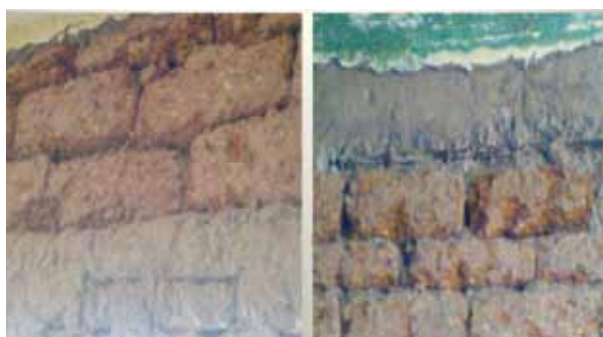
Since the building was very old and located in a coastal area, water leakage and reinforcement corrosion were major issues. There was water leakage on the roof and water seepage through the external walls. The walls were made of laterite stone block masonry. The pointings of the stone masonry disintegrated and water was leaking through these joints. There was spalling of plaster (Fig. 1), cracks in the masonry walls (Fig. 2) and cracks in the ceiling of the RCC roof (Fig. 3). Water seepage and leakage led to the growth of fungus and moss on the walls (Fig. 4) and the

Fig. 1: Spalled plaster, fungus growth on walls

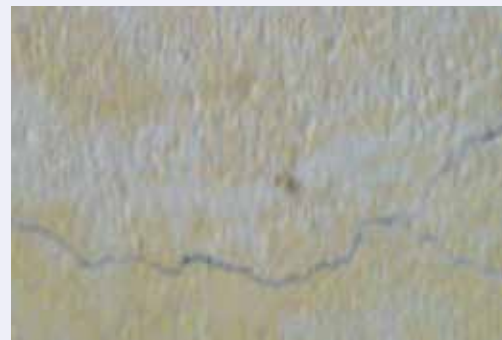
Fig. 3: Cracks in the ceiling

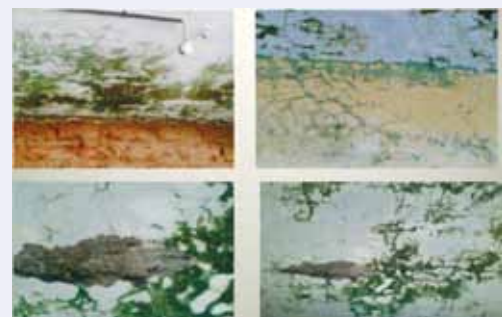
Fig. 4: Fungal growth on ceiling

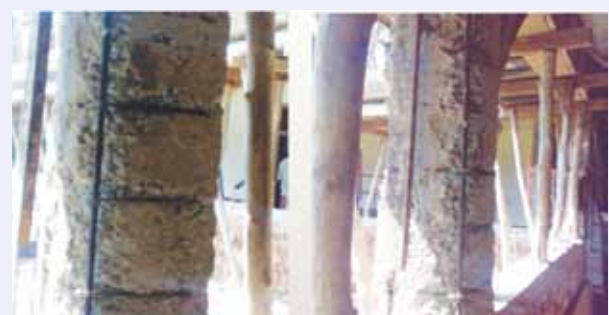
ceiling. The corrosion of reinforcement led to spalling of the concrete. There were cracks in the RCC ceiling and corrosion of reinforcement and spalling of concrete in columns (Fig. 5).

Fig. 5: Corrosion of reinforcement and spalling of concrete in columns

- Distress and spalled concrete portions were identified and marked for repair and restoration.
- Reinforcements were exposed by proper chiseling with a light weight hammer and chisel.
- The exposed reinforcements were properly cleaned with a wire brush and the entire concrete steel surface was washed with potable water.
- Thereafter the reinforcements were applied with a rust remover (**Dr. Fixit Rust Remover**) and rubbed with gunny sacks, wiped properly and washed with high pressure water jet to remove traces of any residue.

- Then the same reinforcements were applied with anti-corrosive epoxy zinc primer (**Dr. Fixit Epoxy Zinc Primer**) to prevent further corrosion.
- After that the distressed concrete portions were properly applied with epoxy bonding agent (**Dr. Fixit Epoxy Bonding Agent**) which acts as an impervious layer for the restored patches.
- Finally cement based ready to use high early strength structural grade repair mortar of **PAGEL U-40** was applied in mortar consistency to build up the thickness for 10-30 mm cover concrete and **PAGEL U-80** for 40-80 mm cover concrete, as needed at site condition (Fig. 8). The ceiling surfaces of the roof slab and beam were also repaired in a similar manner (Fig. 9).

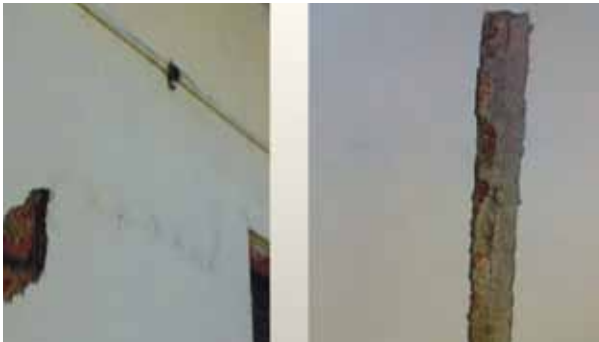
Fig. 6: Cracks in walls

There were some cracks in the masonry walls (Fig. 6). At these locations the plasterings were chipped and V-grooves cuts were made along the length of the crack with a chisel. The cleaning was done with a high pressure water jet. A wire mesh was fixed along the cracks after which the cracks were repaired with cement based ready to use fine repair mortar (**PAGEL U - 10**) (Fig. 7).

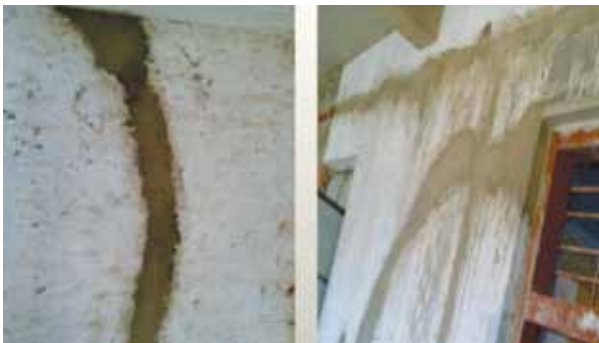
Fig. 7: Plastering cracks repaired

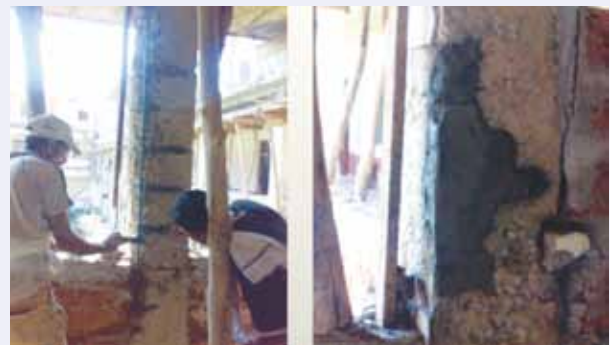
The reinforcements in most of the columns had corroded. There was complete loss of concrete cover in some columns. The following steps were taken for repair and strengthening:

Fig. 8: Columns repaired with structural grade mortar

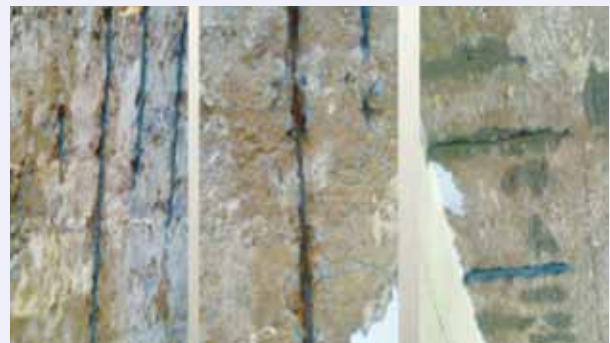
Fig. 9: Repairing of ceiling, beam

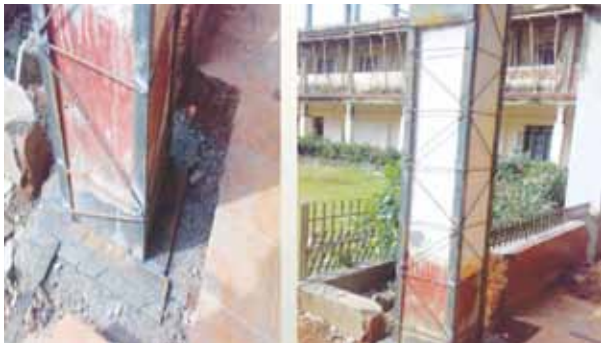
Fig. 10: Strengthening of columns by steel jacking

The columns of the corridor needed to be repaired and strengthened to carry additional load. This was achieved by providing steel jackets to those columns. The steel jackets were made of 4-ISA 75 x 75 x 6 mm and braced with tie rods in a zigzag manner. The concreting was done with cement based structural grade repair mortar (**PAGEL U-80**) (Fig. 10). The properties of cement based repair mortar is given in Table 1.

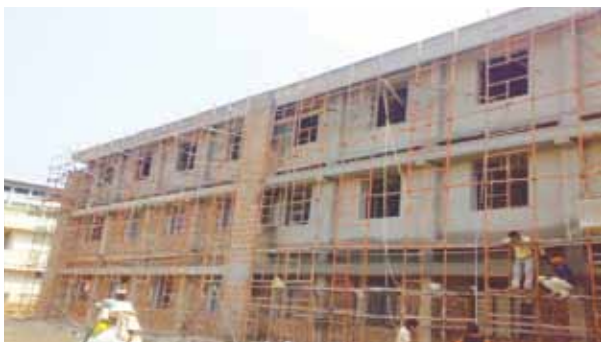
Fig. 11: Plaster finishes with polymer modified mortar

- All the external wall plasters were loosened and debonded from the masonry surface for which plastering was chipped of and replastering was done. It was finished with cement mortar mixed with polymer modified mortar, as shown in Figure 11 (Dr. Fixit Pidicrete URP).

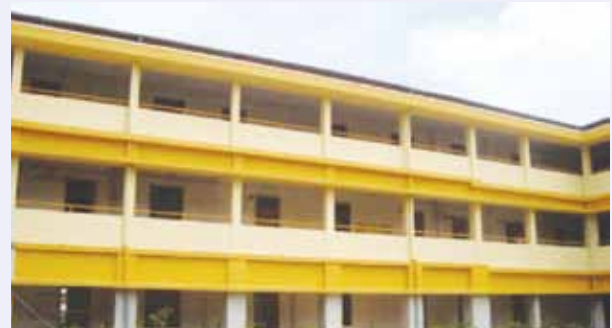
Fig. 12: Surfaces protected with acrylic elastomeric coating

- The surface was applied with an acrylic based primer (Dr. Fixit Prime Seal) to resist efflorescence and to provide excellent adhesion to the surface.
- The surface was finally protected with an acrylic elastomeric coating (Dr. Fixit Rain Coat) (Fig. 12). It is a water based coating with hairline crack bridging ability. Since this coating has higher thickness of 125 micron in two coats, it can provide a relatively longer service life of 6-8 years. The coating is also algae and fungus

resistance and having higher dirt pick up resistance. As a result it can maintain a clean surface.

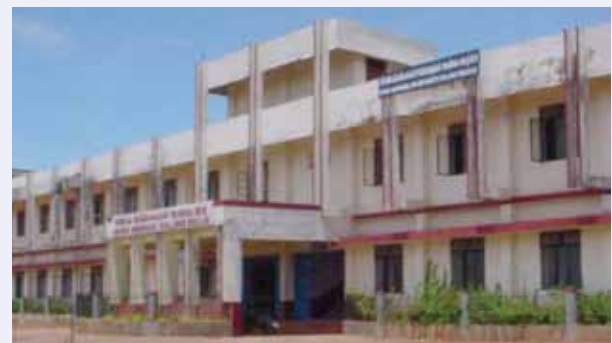
Fig. 13: Before repair in distress conditions

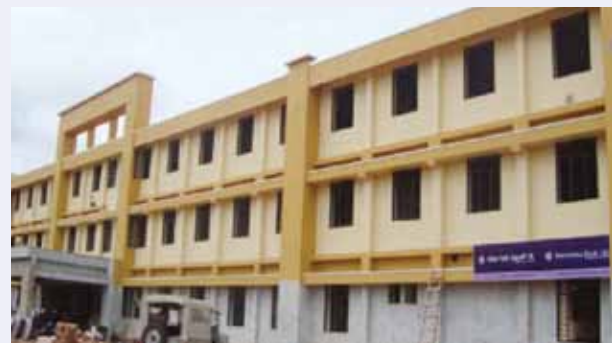
Fig. 14: View of the same building after repair, strengthening and with an additional floor

The building repair and waterproofing were carried out with construction chemical materials in order to increase the service life of the structures. Non-destructive testing helped for proper diagnosis, to assess the existing load carrying capacity of the member of the structure for repair and strengthening and to take a decision for the construction of an additional floor. The photograph before repair of the building is shown in Figure 13 and after repair with the additional floor is shown in Figure 14.
