Case Studies of Remedial Treatment of Water Retaining Structures

1.0 Ferrocement Lining for Leak Proofing of a Swimming Pool

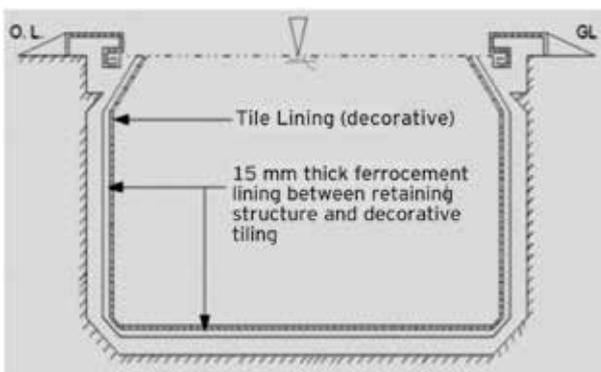
Anchored ferrocement lining provides an excellent effective leak-proof surface inside leaking masonry and concrete tanks as a cost effective rehabilitation. The present case study discusses the treatment for an old swimming pool with leakage through walls, base, joint between wall and floor which was carried out in the following steps.

Fig. 1: Ferrocement treatment of the swimming pool

- Fixing of one more layer of mesh reinforcement and applying one more layer of polymer mortar in the same manner as given in Fig. 1. Then repeat to provide specified no. of layers of mesh and mortar layers to build up the designed thickness for lining.

- Application of finishing surface such as tiling or epoxy / PU paint etc.
- Fig. 1 provides a view of FC lining over swimming pools - for new swimming pools, the continuous lining is provided in between the retaining structure and finishing surface.
