ReBuild

Vol. 8 No. 3 (Jul - Sep 2014)

NON-DESTRUCTIVE TESTING (NDT) PART - 4

**WATER LEAKAGE DETECTION IN BUILDINGS &
WATERPROOFING MEMBRANE INTEGRITY TESTING**

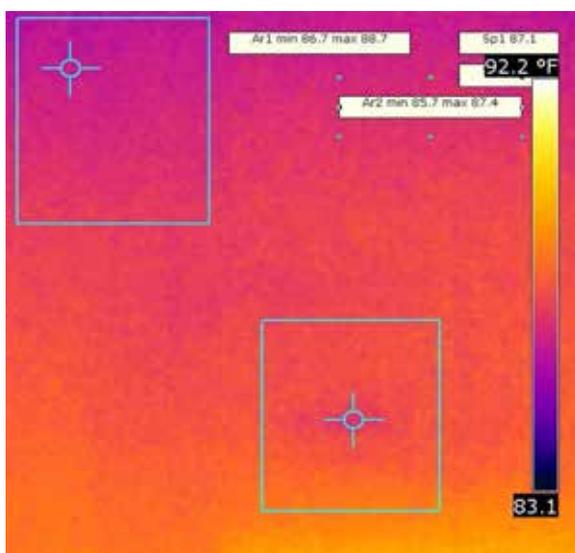
- Dampness in the ground floor bathroom slab area coming from 1st floor bathroom (Fig. 2).
- Concealed Nahani trap (Fig. 3) and pipe line have deteriorated which need replacement.

Fig. 2: From ground floor ceiling

After locating the leakage spots the remedial treatment was successfully carried out, after which no leakage was observed.

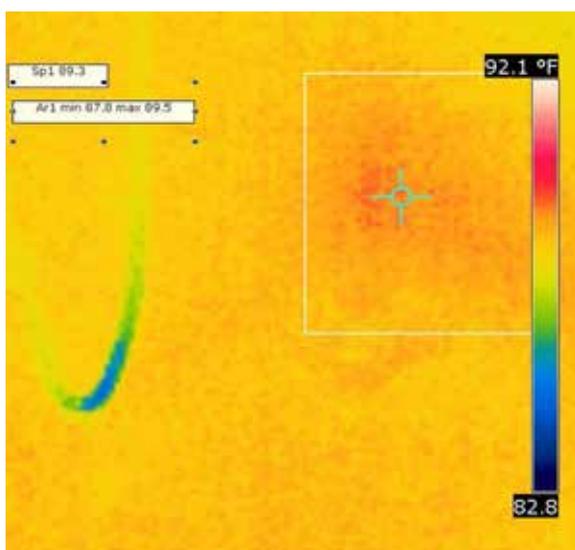
Fig. 3: 1st floor bath room near Nahani trap south wall joint

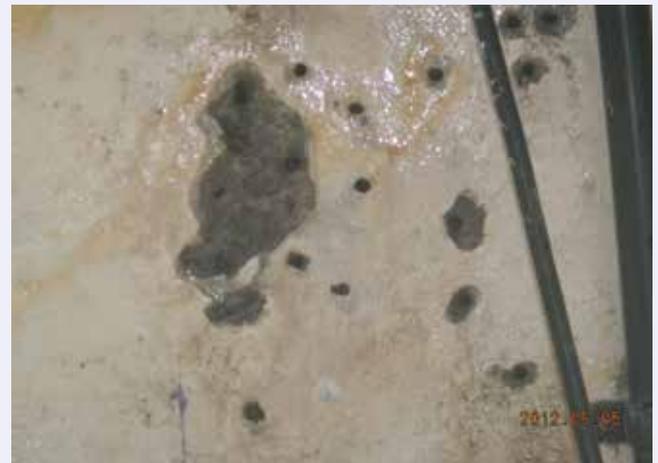
In a 27-storey posh residential tower in south Mumbai, leakage was occurring at the 12th floor roof slab. It was observed that water was dripping from one point at continuous intervals (Fig. 4).

Fig. 4: Water dripping point and accumulation of water of 12th floor roof ceiling

The remedial waterproofing treatment was carried out after which no leakage has been observed so far.

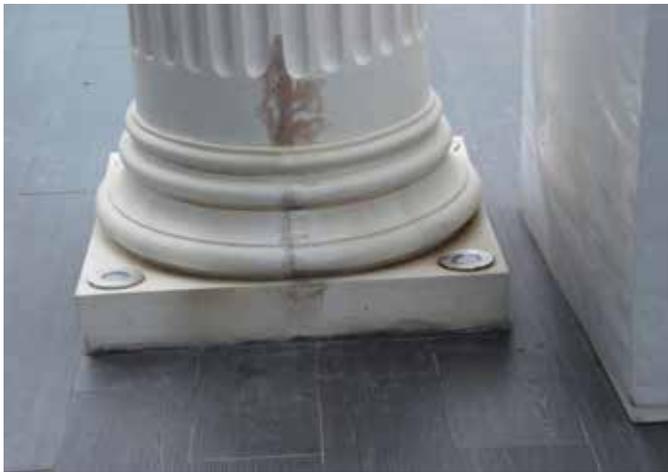
Some drillings were carried out on ceiling surfaces (Fig. 4) to release the water pressure. The water drop varied between 30 to 50 drops in each 10 minutes interval and increased with heavy rain but decreased without rain. The same water was being accumulated in a larger area and was dripping slowly when there was no rain. At the 13th floor, all the water spread areas such as the deck slab, water fountain, artificial water pond, back side of the fountain, were tested by visual observation, water ponding test and thermal imaging. Except for the deck slab, the other locations were ruled out as causes of the leakage. The deck slab of the 13th floor was double height of 8.4 m, without any facade protection. During the monsoons the rain water was splashing on the deck floor. Though the deck had a provision of water proofing, a leakage occurred due to a failure of the waterproofing at one transition zone of a pillar. After conducting thermal imaging, the exact location point was identified. The digital image and thermal imaging of the same spot is given in Fig. 5 & Fig. 6 respectively.

Fig. 5: View of 13th Floor deck slab floor near pillar

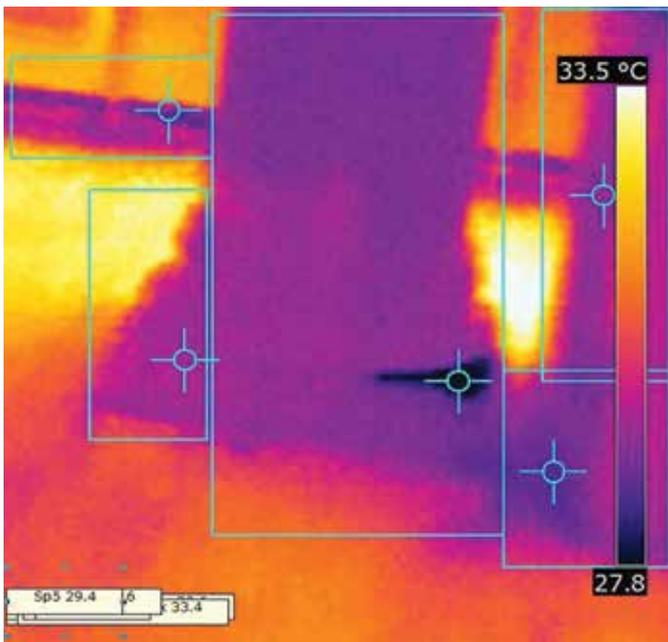
Fig. 6: Infrared thermal imaging showing gap at joints of pillar where water was penetrating

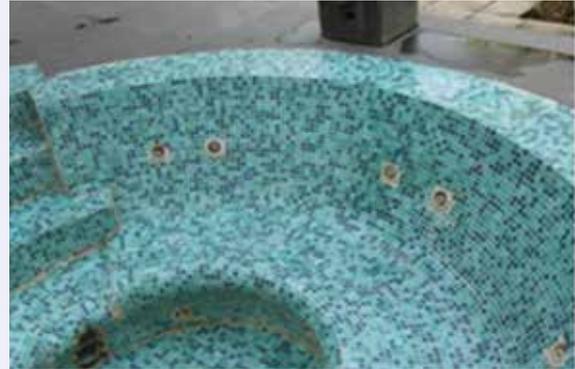
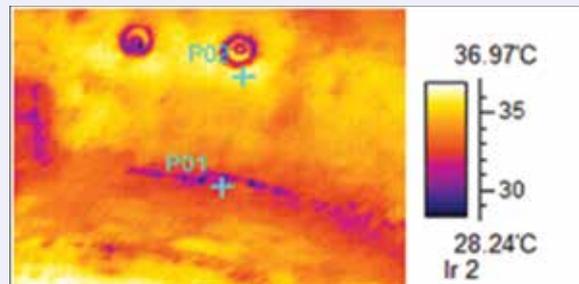
Fig. 7: Digital Image of leakage spot

Fig. 8: Temperature :P01- 30.8°C Min.; P02- 36.4°C (Max.)

The leakages spots were identified in all the thermal images and accordingly remedial treatment was carried out after which no leakage was observed.

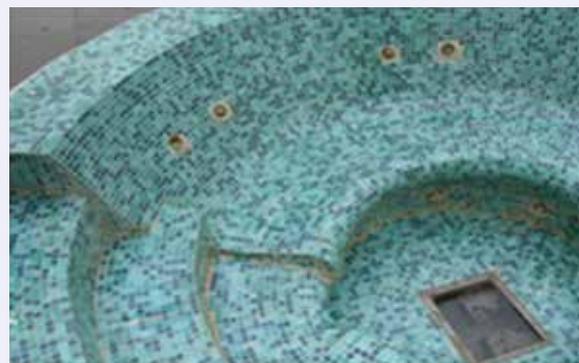
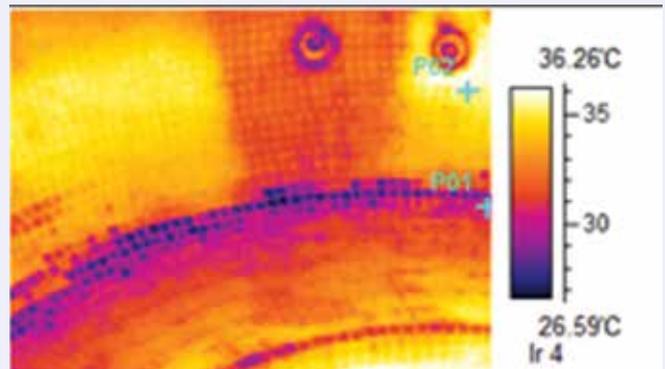
Fig. 9: Digital Image of leakage spot

Fig. 10: Temperature : P01- 27.7°C Min.; P02- 36.1°C (Max.)

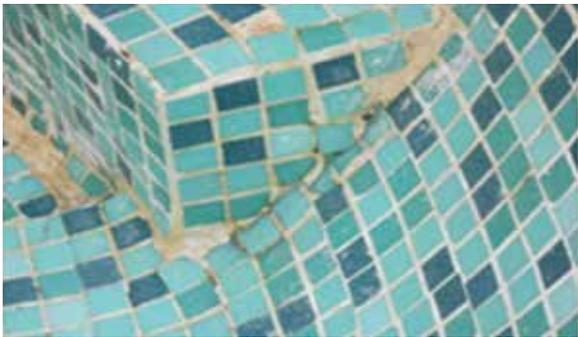
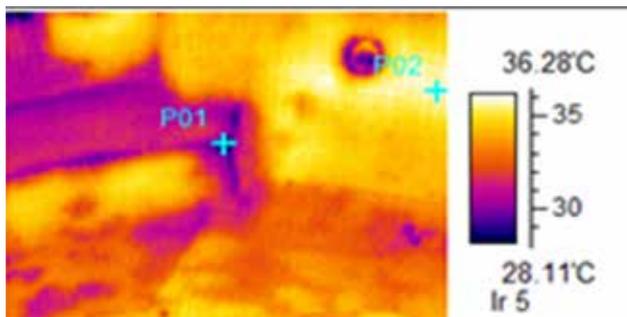
Fig. 11: Digital Image of leakage spot

Fig. 12: Temperature : P01- 28.2°C Min.; P02- 36.1°C (Max.)

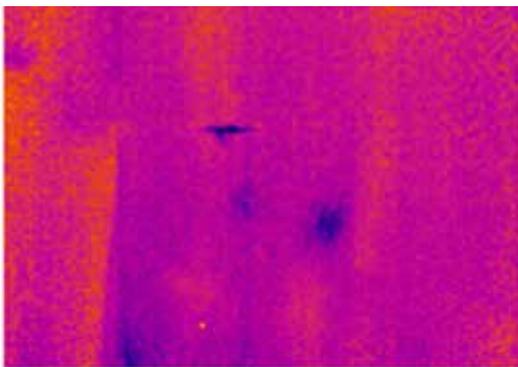
Fig. 15 indicates the location of the water within the wall as it moves behind the wall, surfacing at the top and bottom of the window. At this point of the test water was dripping from the window header on to the floor of the living room. Water testing continued with the spray rack positions at different locations. As the rack moved away from the valley of the roof the water intrusion decreased, finally stopping with the completion of the water testing.

Fig. 15: Thermogram showing the beginnings of the water intrusion

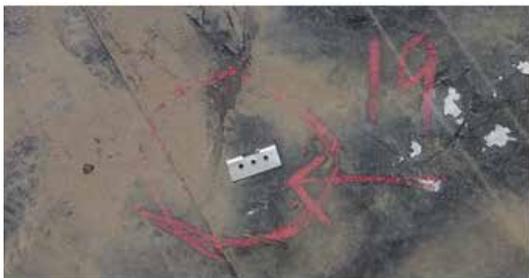
Fig. 5: Breach no 19 as detected by EFVM test

EFVM testing gives an exact location, making repairs simple and quick without any additional inspections required from the contractor. A report was issued to the roofing contractor listing all breach locations and a plan drawing as well for reference. Once all repairs had been made and retested, all of the overburden was put in place and the plaza deck was completed (Fig. 7).

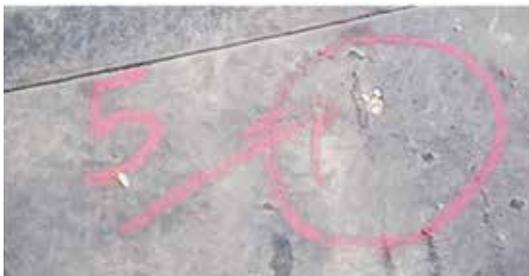
Fig. 6: Breach no 5 as detected by EFVM test

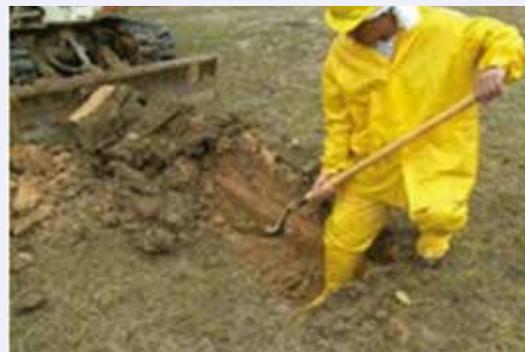
Fig. 8: Pinpointing the leakage location and further removal of overburden for remedial treatment

Since the vector wire was not installed prior to the dumping of soil, the technician had to weave a temporary wire through the soil around the lid area. Because the soil acted as a conductor, the EFVM test could be conducted and the readings obtained were strong. The technician was able to locate multiple breaches. Once a breach was located, the technician placed numbered landscape flags to allow for excavation of the soil (Fig. 8) and subsequent sheet membrane repair. The contractor made the repairs (Fig. 9) and the areas were retested

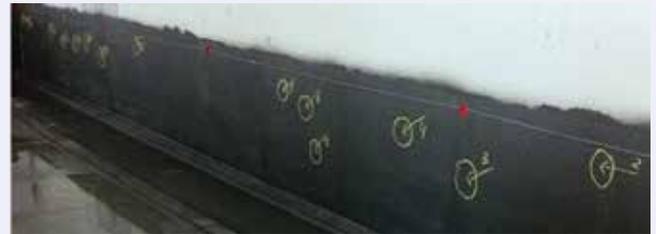
Fig. 11: Breaches identified by vector mapping test on vertical surfaces of the membrane

of vertical waterproofing installations. With millions of square footage of vertical waterproofing being installed every year, a method of vertical testing was conducted and accordingly remedial waterproofing (Fig. 12) was made.
