ReBuild

Vol. 10 No. 4 (Oct - Dec 2016)

STRENGTHENING OF CONCRETE ELEMENTS Part-4

Arresting Leakages on the Inside Walls of Inspection Gallery (Muran Dam) of Upper Indravati Hydro Electric Project, Odisha - A Case Study

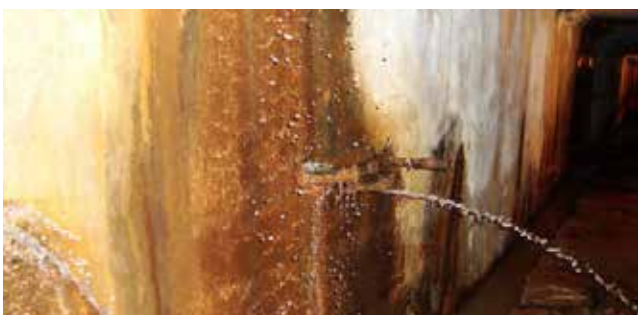
The dam safety deficiencies were heavy leakages in the drainage gallery of the dam (Fig. 2). As per the measurement taken (October 2007), the rate of leakage of water was 44.19 litres per second. Thus, due to delay in execution of the work from January 2005 to December 2008, there was loss of water of 5.58 MCM (Million Cubic Metres) which would have generated 4.82 MU (Million Units) of electricity valued at ₹ 2.4 million.

Fig. 2 : Water leakages in the drainage gallery.

The Inspection gallery walls were in a situation where the leakages were just like fountains as the water behind the

Water spurting out under pressure was obviously dangerous to the health of the dam and it could have spoiled the strength of the inspection gallery walls. In order to overcome this danger the walls needed to be sealed properly to avoid further degradation and the wall structure from water ingress and associated durability problems.

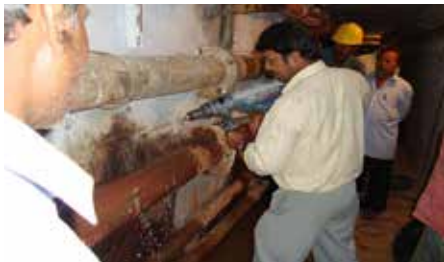
Fig. 3. Drilling holes with drill machine

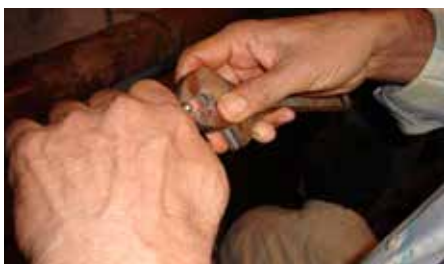
Fig. 4. Instalation of packers in the holes.

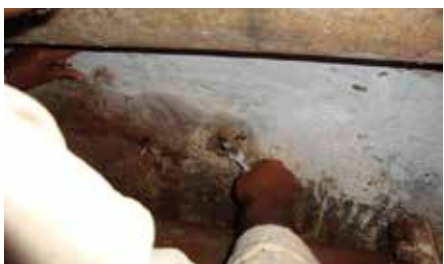
Fig. 5: Screwing of packers tightly.

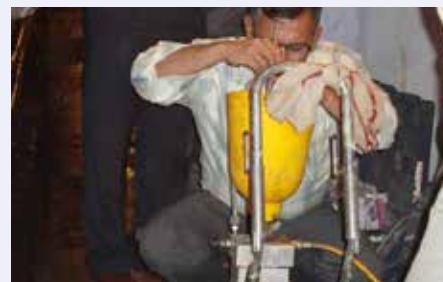
Fig. 6: Pumping being ready after mixing of materials

The Pump was made ready along with a two-part Polyurethane injection material (Fig. 6). It was ensured that mixed material was used immediately as the high air humidity might cause a skin formation over the material surface.

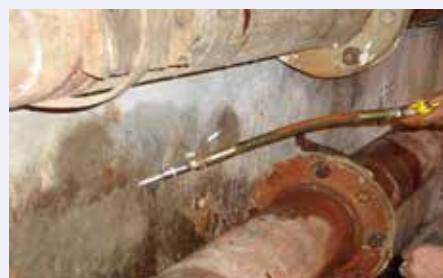
Fig. 7: PU Injection in process

The PU injection was carried out at intervals so that it could be understood intermittently from the reaction of the material with moisture inside whether to continue or stop the injection process (Fig. 7).

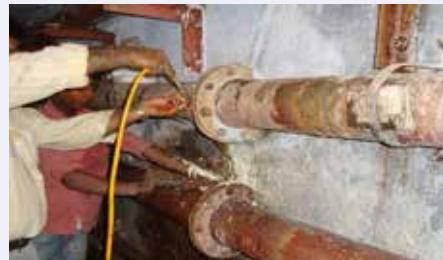
Fig. 8: Continuing with secondary PU Injection

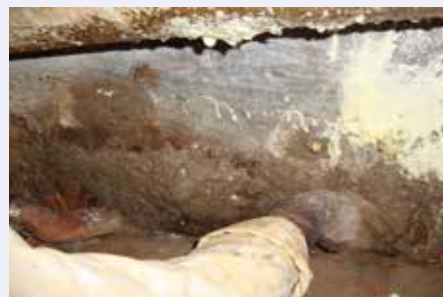
Fig. 9: Filling the drill holes with polymeric grout.

the drill holes were closed with suitable mineral binding materials (rigid quick-binding cement, swelling mortar etc.) The closure of drill holes in this case is shown in Fig. 9.

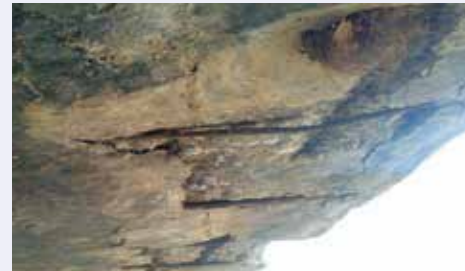
Fig. 1: Spalled concrete at the edges

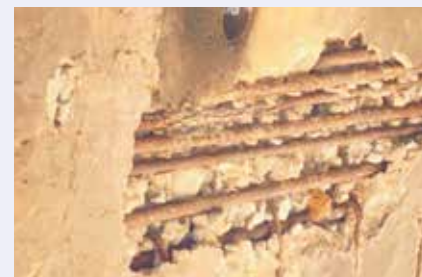
Fig. 2: Spalled concrete and reinforcement corrosion

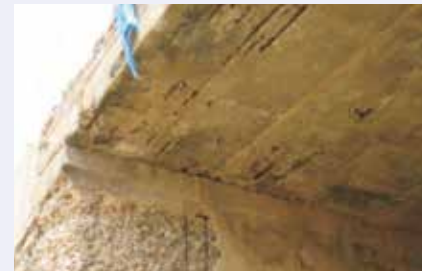
Fig. 3: Spalled concrete in the piers

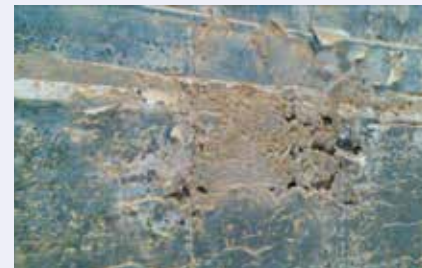
Fig. 4: Honeycombs

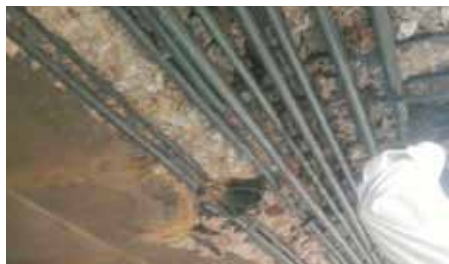
Fig. 6: Anticorrosive treatment to corroded reinforcement after rust removal

The entire steel surfaces were coated with an anti-corrosive epoxy zinc primer (Fig. 6) in two coats. It was a two-component system based on metallic zinc and epoxy resin, hardener and additives. Active zinc-rich system combated corrosion by electro-chemical means. It actively resisted corrosion within the confines of the repair location and avoided the generation of incipient anodes in immediately adjacent locations. It bonded strongly to cement concrete and mortars.

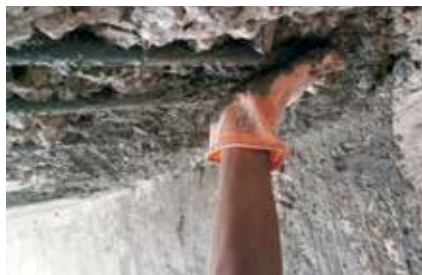
Fig. 7: Applying structural grade mortar

At some places where only spalling had occurred up to 80 mm thick, shuttering was not required. A cement-based ready-to-use structural grade mortar (Fig. 7) was applied at those places.

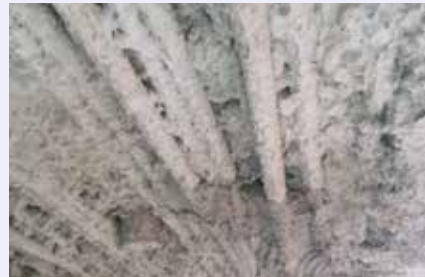
Fig. 8: Repair work carried out by structural grade mortar

Repair mortar was applied tightly by hand (Fig. 8) on the

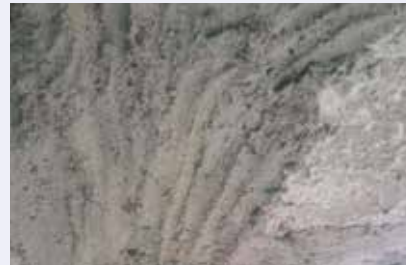
Fig. 9: Finishing of spalled repair

repaired surfaces and finishing was done (Fig. 9).

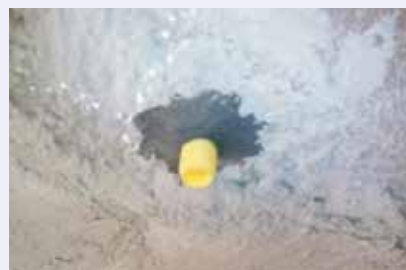
Fig. 10: Injection location point

At places of honeycombs and small cracks, injection points were selected (Fig. 10) and holes were drilled by a drilling machine. The drilled holes were cleaned and pressure washed. The non-return valve nozzles were driven through those holes and sealed with epoxy putties for facilitating injections (Fig. 11).

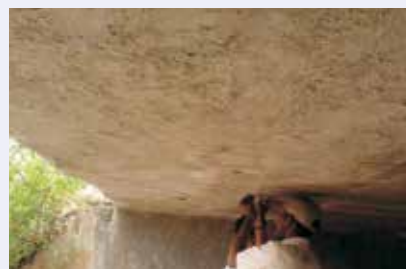
Fig. 11: Fixing non-return valve nozzle for injection

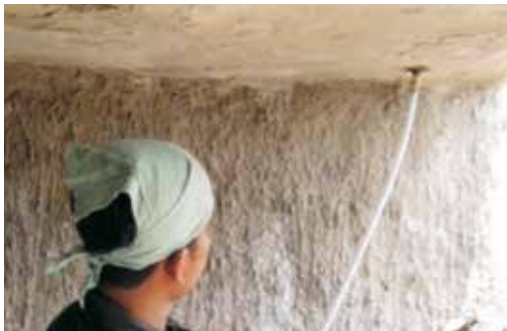
Fig. 12: Epoxy injection through nozzle

A 2-part epoxy injection grout was injected (Fig. 12) with pressure grout equipment having capacity of 40 psi (0.275 MPa), through non-return valve nozzles.

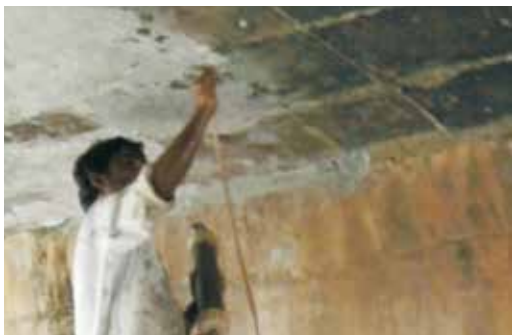
Fig. 13: Epoxy injection in progress at different location

After completion of the injection, the pumping equipment was shifted to a different nozzle location and again injection was made at new location (Fig. 13) and thus entire area was injected for strengthening.

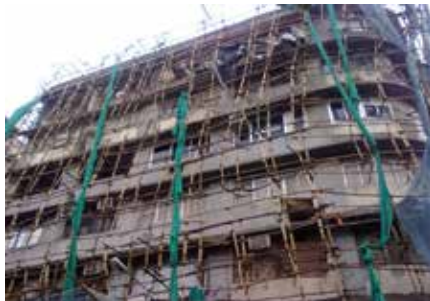
Fig. 1: Continuous sunshade being provided

It was suggested that a continuous sunshade Fig. 1 be constructed for protection against rainwater, instead of the old sunshades just over the window openings. This helps prevent water running over empty spaces along the walls that results in the growing of moss and fungus, which causes the appearance of black spots and spoils the paint. All new re-bars were anchored to the beam with the help of FISCHER epoxy resin capsules and 100 mm thick reinforced concrete was cast uniformly with the help of waterproof ply shuttering.

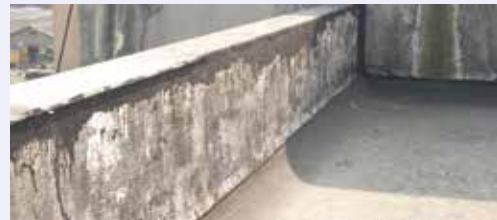
Fig. 2: RCC coping before

To prevent leakage on top of the parapet, RCC coping was laid over at a height of a 1.04 m parapet wall with 25 mm projecting outside, 75 mm projecting inside and a top finish of a 25 mm inward slope. Making shuttering on three sides has no complication because of the scaffolding support. The fourth side was also cast with additional safety measures. RCC coping before and after are shown in Fig. 2 and Fig. 3 respectively.

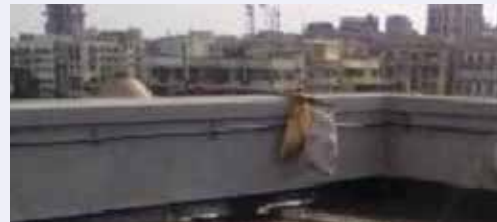
Fig. 3: RCC coping after

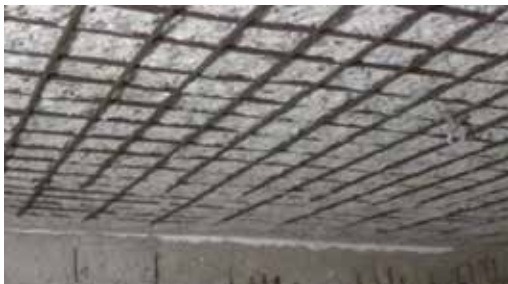
The beams and slabs in the basement were damaged Fig. 4 due to leakage from the common WC block on the ground floor. A complete beam was jacketed in micro concrete by drilling a hole from the top floor. A portion of the slab bottom sagged and de-bonded. By providing watertight shuttering, slab casting was done using micro concrete with 6 mm down pea gravels poured from the top floor by making a few core cuttings for maximum flow up to 2 metres Fig. 5. Similarly the damaged columns were strengthened were micro concreting. Fig. 6 and Figure 7 show the column before micro concreting and column after micro concreting respectively.

Fig. 4: Roof slab before micro concreting

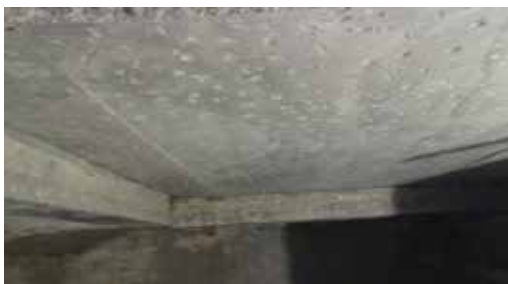
Fig. 5: Roof slab after micro concreting

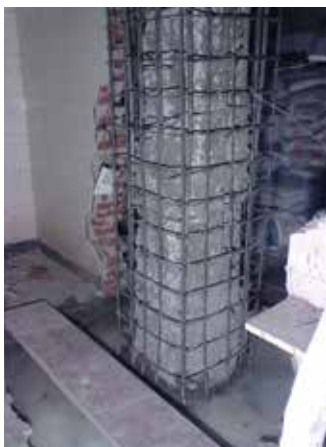
Fig. 6: Column before micro concreting

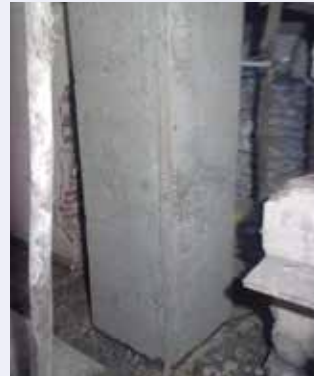
Fig. 7: Column after micro concreting

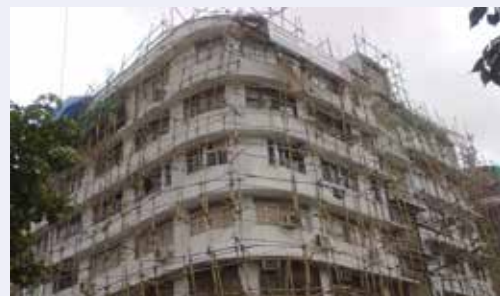
Fig. 8: View before repair

The external surface of the building was protected again with good quality coating that had elastomeric properties. A hand roller was used for application instead of a brush. Three coats were applied with the hand roller as per manufacturer recommendations. Acrylic coating was used having crack bridging properties. This is very important for old buildings. A five year warranty against leakage was received and given to the client stating that the manufacturer will give free material during the tenure of the contract and the contractor will apply the material at no extra cost to the Society during the defect liability period. Such work will start within a week after a written intimation of complaint is submitted. The work will be done under supervision of the consultant till the defects are rectified. Fig. 8 and Fig. 9 show the view of building before and after repair.

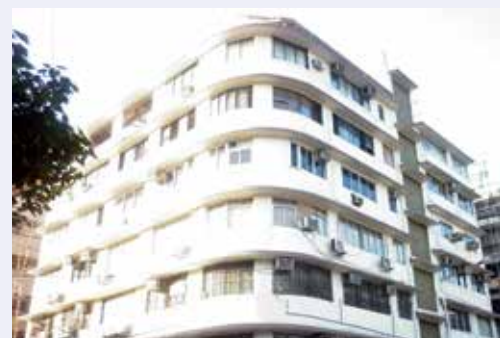
Fig. 9: View after repair
