Damage Assessment in the Basement during Remedial Works

[Excerpts from "Code of Practice for Remedial Waterproofing of Structures below Ground"; 2008 of PCA (Property Care Association)]

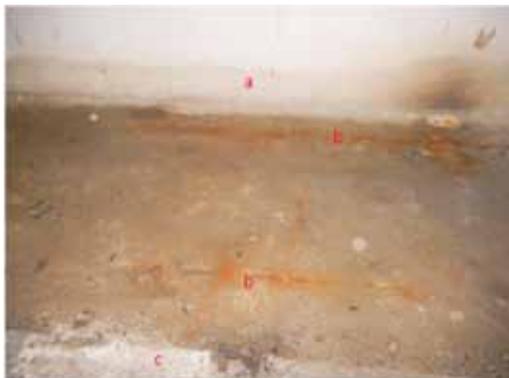
Fig. 1: Damages in basement walls and floor

- Watermarks due to capillary rise at floor of basement wall
- Brown marks indicating the reinforcement corrosion in basement floor
- White patches on basement floor

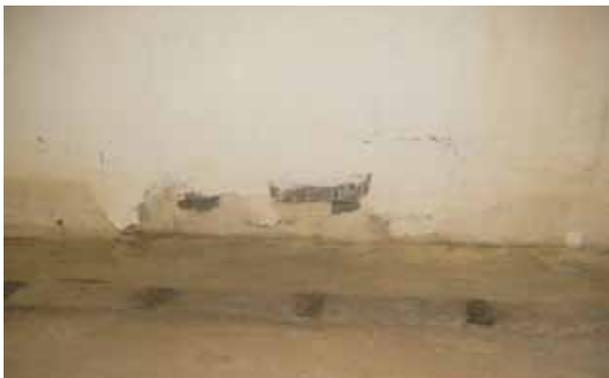
Fig. 2: Spalling of concrete due to corrosion in basement wall at floor level

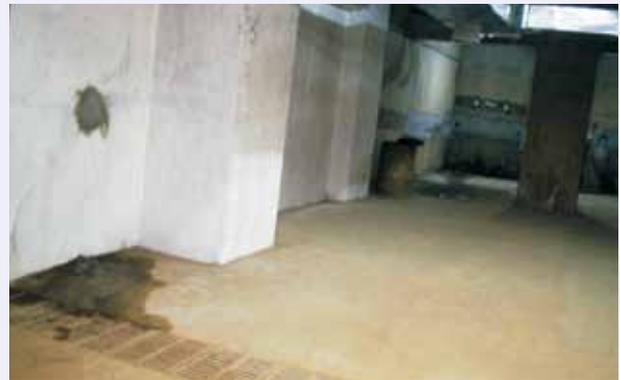
Fig. 3: Dampness and seepages in basement
