Case Studies of Remedial Waterproofing and Repair of Basements

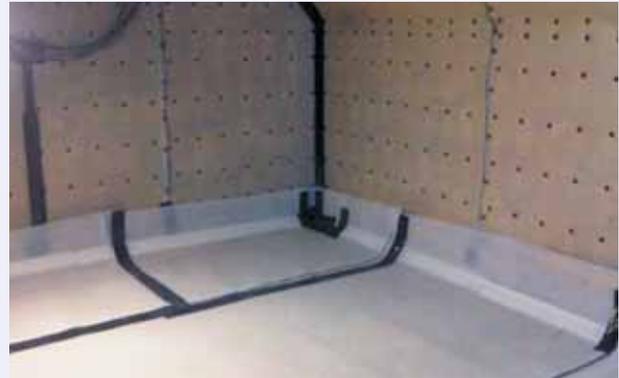
The source of the water ingress was through the drypack construction joints between the existing brickwork footings and the underpin. With the situation looking desperate, the design and build contractor called a specialist basement contractor to provide a fully guaranteed basement waterproofing solution.

Fig. 1: View of cavity drain installation

With such extreme amounts of water entering the through the pins, the flow of water needed to be slowed down significantly in order to put in a maintainable and guaranteed basement waterproofing system into the construction. Two basement contractors specialized in cementitious system and cavity drained waterproofing system respectively put together a combination of fast setting cementitious products into the specification to deal with the problem. Initially the flow was impeded using a water plugging compound, a fast acting cementitious product which cures within 40 seconds of contact with water. Once the same product was applied to a 300mm band each side of underpins then followed by two coats of flexible cementitious slurry to support and stop as much water as possible. Once the cementitious slurry products were applied then the full internal drained cavity system was installed (Fig.1). This included cavity mesh wall membrane curtain hung down (Fig.2) the earth retaining walls terminating into the base drain for allowing the water to be drained to the sump for further pumping.

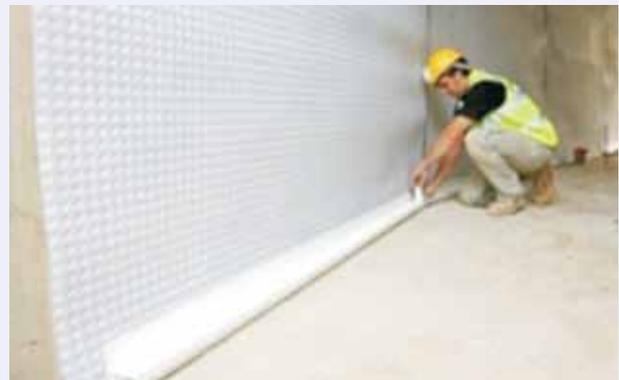
Fig. 2: Cavity mesh wall membrane curtain being hung down during installation
