PERFORMANCE OF FRP STRENGTHENED REINFORCED CONCRETE COLUMNS AT VARIOUS LEVELS OF REINFORCEMENT CORROSION - AN EXPERIMENTAL STUDY

PERFORMANCE EVALUATION OF ENGINEERED CEMENTITIOUS COMPOSITE AS A MATERIAL FOR REPAIR AND RETROFIT

Vol.1, No.3, 2010, 126-134

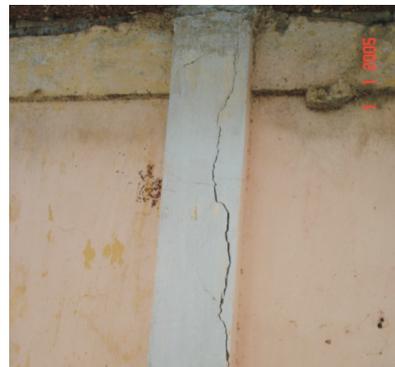
Figure 1. Effect of corrosion of reinforcement in longitudinal cracking in column.

One of the main reasons for lack of poor long term structural performance under sustained static loading is the corrosion of the reinforcement which results into cracking (Figure 1) and spalling (Figure 2) of concrete due to poor resistance of concrete in tensile stress as shown in Figure 1. Poor structural performance can not be just improved by increasing the compressive strength of concrete as it leads to increase in brittleness. Corrosion of the reinforcement may get initiated at slower rate even in crack free cover material because of carbonation, presence of chlorides from cement or chemical admixture, presence of some moisture in the form of free water etc. Corrosion process produces bursting force which induces axial tension in the cover concrete in which concrete is very weak resulting into cracking parallel to the reinforcement. Corrosion process may become faster with ingress of water, chemical etc. through these cracks. Also, alkali-aggregate reaction exerts tremendous pressure on outer surface resulting into cracking in the material. Therefore, the most urgent need in concrete repair is to somehow enhance the mechanism of resistance to axial tension.
