Restoration of Historic Massive Masonry

A lecture given by Dr. Casper Groot under Healthy Construction Series organised by Dr.Fixit Institute of structural protection & Rehabilitation at Kolkata & Delhi in June 25 / 26, 2009 on "Restoration of Historic Massive Masonry". The following is the zeast of his lecture based on work done by RILEM Technical Committee. (International Union of Laboratories and Experts in Construction Materials, Systems and Structures.).The main objective of the Technical Committee is to provide Technical guidance for consultants and practitioners through publication of required characteristics of the various types of repair mortars (pending mortar, render and plasters, repainting mortar etc). Since many mistakes are made in practice in choosing repair mortars for historic (pre-existing) masonry which results in damage of the existing historic masonry.

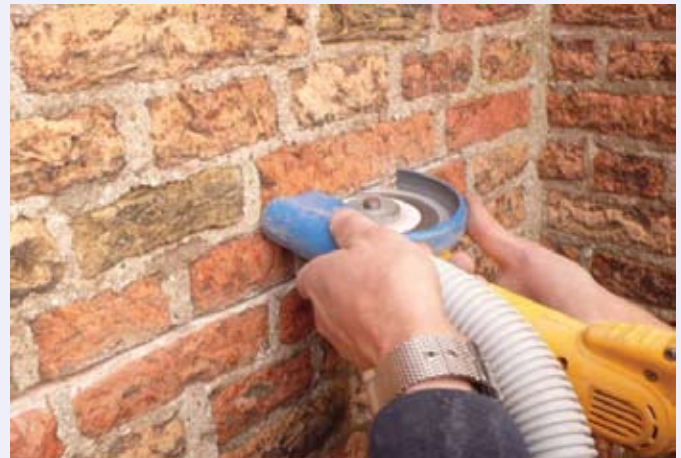
Fig: 6 Raking out of joints mechanically

Apart from material characterization the execution of the work is an essential element of the soundness of proposed repair. The repointing practices such as raking (manual & machine) expansion groove, mortar joint section repointing etc. has been highlighted in figures 6 and 7. For this a clear rectangular space instead of a V-shaped joint must be raked in the mortar joint of width not less than twice the joint thickness for placing the repointing mortar.
