Moisture Ingress through Basement Walls Rectified with Crystalline Materials

[Excerpts from News Bulletin of ACRA (Australian Concrete Repair Association)]

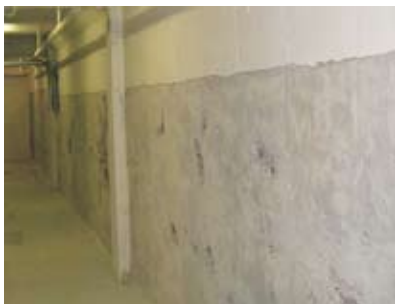
Fig. 1: Surface prepared for application of crystalline coating

Preparation for the basement wall involved the removal of existing paint and other contaminants from areas that were damaged from water ingress. Additionally, all deteriorated concrete areas were pressure-washed to provide an open capillary, clean absorbent surface, and bony and honeycombed sections were chipped out to a square-edged substrate and surface laitance was removed. The surfaces were prepared for application of crystalline coating as shown in Figure 1.

Upon successful completion of surface preparation, the substrate was saturated with water and crystalline

was applied as a slurry coat to treat the exposed steel and reinstate a passive alkaline barrier around the reinforcement. A high-build repair mortar for the patching and resurfacing of deteriorated concrete was then used to repair back to contour with the surrounding concrete.

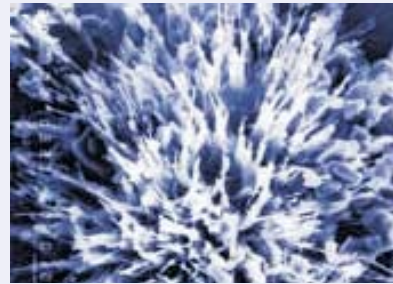
A dense, fully-developed crystalline structure had formed within the capillary tracts of the concrete to completely block the flow of water after application of crystalline at a depth of 50 mm into the concrete sample at 28 days (Fig. 2).

Fig. 2: Crystallization being formed for blocking capillaries
