ReBuild

Vol. 6 No. 3 (Jul-Sep 2012)

WATERPROOFING

REMEDIAL WATERPROOFING OF BASEMENT

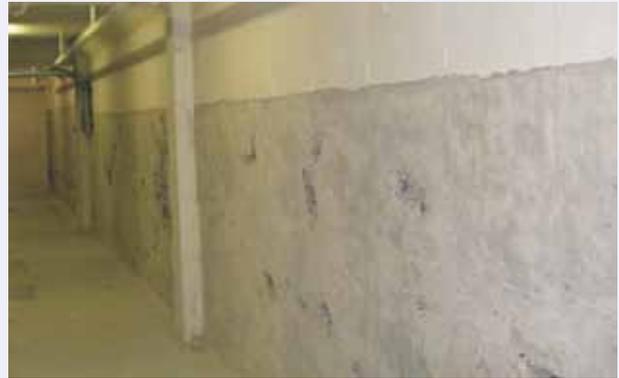
Fig. 1: Crystalline waterproofing on negative side

The “crystalline” basement waterproofing systems is more popular for negative side application. It consists of a liquid solution of cementitious base which is applied to an existing concrete surface. Also called a “capillary” basement waterproofing system, the solution penetrates into existing concrete and seals the capillaries within the concrete mass. Proprietary chemicals within the solution react with lime in the concrete to form needle like crystals which fill the capillaries and reduce the permeability of the concrete. Moisture must be present in the concrete in order to form the chemical reaction. Water entering through the crack reactivates the chemicals and causes new crystals to form and grow, which self-seal the new cracks and maintain a watertight seal for which it is a permanent crack repair solution. This self-sealing property is one of most unique and useful features and can often reduce long-term maintenance and repair costs if only active crystalline forms. The crystalline basement waterproofing system gives the contractor an option when the owner does not have the budget to do a positive-side job or approach to the positive side is not possible because of space constraint. This system is more of a maintenance program than a repair. The general idea is to apply the material to the concrete and then wait for the moisture to seep in from the outside. The chemicals dissolve and follow the water, sealing up the cracks and capillaries in those zones of moisture. The next month or the next year, it may be necessary to apply more solution as the chemicals seep into the zones of moisture and are used up. The effectiveness depends upon the amount of moisture penetrating into the basement and the ability of the crystalline system to form crystals in passive state. Rather than one time remedial solution it can be a regular maintenance system. Since it is a negative-side basement waterproofing system on existing structures it has huge advantage. The removal and replacement of the perimeter soil and other improvements is not required. However, a negative-side system which offers the level of protection one get from a positive-side application can not be compared. The Fig. 1 shows that basement wall applied with a crystalline coating.

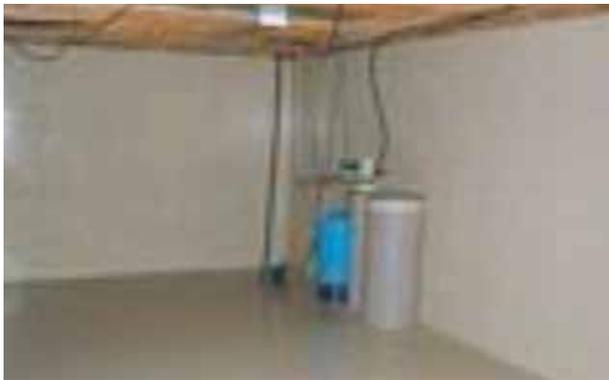
Fig. 2: Injection equipment setup

The injected polyurethane (PU) material is

“hydrophilic” or attracted to water. The drilled holes are used as injection points and also to gauge and monitor the penetration of the material. Crack sealing can also be accomplished by injecting “hydrophobic” polyurethane into the cracks. The urethane and bentonite injection systems provide an alternative to the capillary system for basement waterproofing of existing underground structures. Though significantly more expensive than the capillary system, bentonite or urethane injection offers a positive side application. When used on concrete floors- whether above or below grade- bentonite or urethane injection is a less-expensive option than membrane applications which require the removal and replacement of the concrete, exterior soil and other perimeter improvements. PU foam injection carried out in a deep basement for arresting the water leakages is shown in Fig.3.

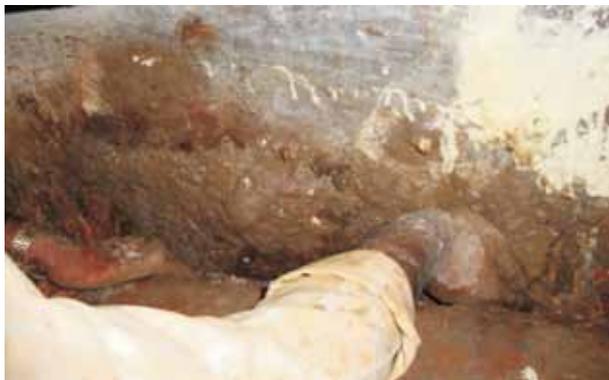
Fig. 3: Foam injection carried out in a deep basement wall

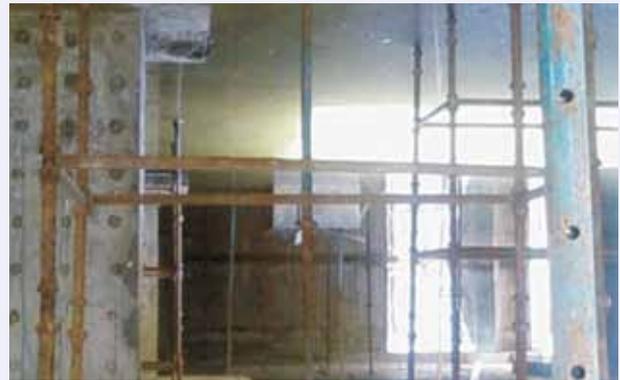
Fig. 4: Grouting of basement wall

the job. Fig. 4 shows grouting carried out in a basement wall. Where ever rising dampness in the basement is the concern the grouting should be made with a Silicone based material as shown in Fig.5.

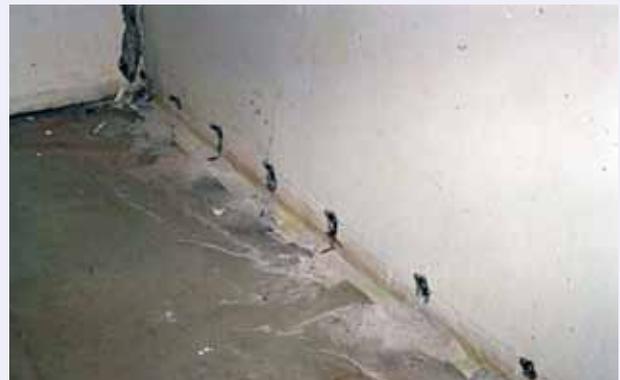
Fig. 5: Injection to basement wall at floor level for preventing rising dampness

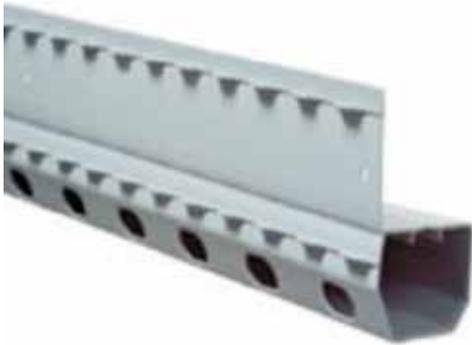
Fig. 6: A view of interior footing drain pipe channel with perforations for collecting and draining water

drain, but unlike the traditional footing drain it sits on top of the footing and prevents debris from entering the pipe thus eliminating clogs. It is installed next to basement wall, on top of the footing, and collects water seepage from the walls, floor-wall joint, wall crack and pipe penetration .

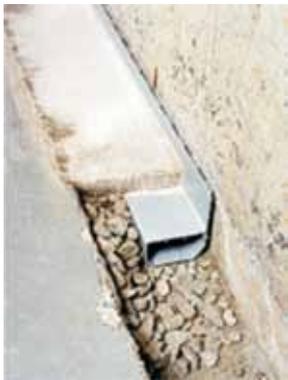
Fig. 7: Installation of footing drain pipe at wall and floor junction

This system works with the sump pump so any water that's collected is removed. As with any waterproofing system of this type, this method leaves a gap between the floor and wall (Fig.7) that allows water from the wall to flow down into the drain. When this system installation begins, the perimeter of the floor is removed. This process is used on the floor only. The footing and foundation are not damaged by this process. If there is any block foundation walls, weep holes are drilled into each core of each block so that the water contained within the hollow cores of the wall is continually drained away. Clean gravel is laid down on the bottom of the trench that has been removed around the perimeter. Specially manufactured rectangular drainage pipe is laid on top, and then gravel is laid on top. Once this is completed, concrete is laid back down on top of the system, it's smoothed over and the area is cleaned.

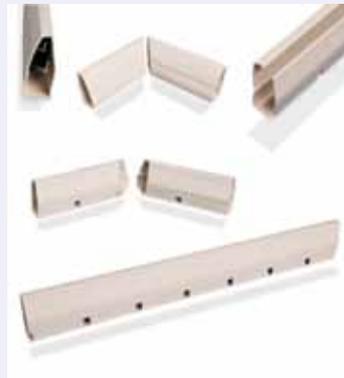
Fig. 8: PVC base board channels with square inlets for drainage in basement with different laying arrangements

One of the most effective and least invasive methods of waterproofing a basement is with a baseboard drainage system. With this system, weep holes are drilled into the floor/wall joint or, in the case of a block wall, into the walls themselves. This relieves the hydrostatic water pressure. Once this is done, a hollow vinyl baseboard or PVC base board having square inlets (Fig. 8) is fixed to the floor. The water creating hydrostatic pressure on the foundation walls is directed into the system and drained to a sump pump system.

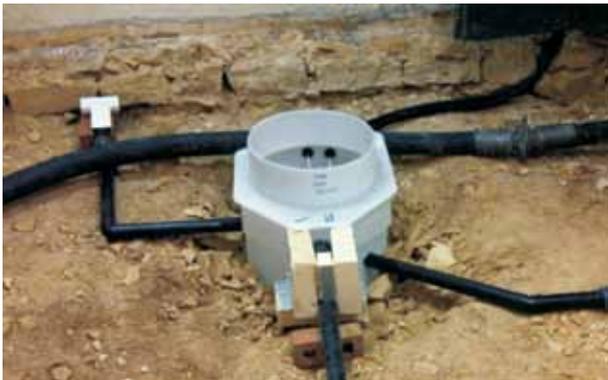
Fig. 9: Sump chamber for housing two medium duty Pumps

The French Drain system is designed with a grated opening on top that collects water and sends it to sump (Fig.9) to a perimeter drain. It is designed with a half-round pipe section, with a grated top fitting. When installed, it's flush with the rest of the concrete floor for

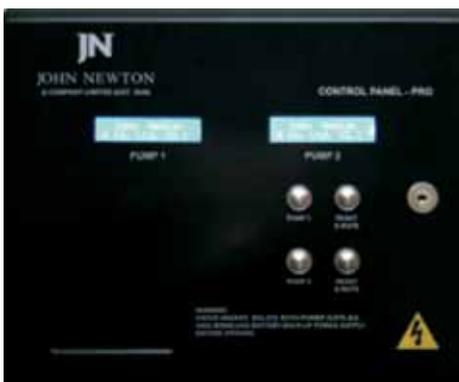
Fig. 10: Control Panel provides advanced power back-up and telemetry systems for automatic pumping
