# ReBuild

Vol. 3 No. 4 (Oct-Dec 2009)

## Preservation, Rehabilitation and Restoration of Historic Structures

### A Case Study Of Lord Jagannath Temple at Puri, Orissa

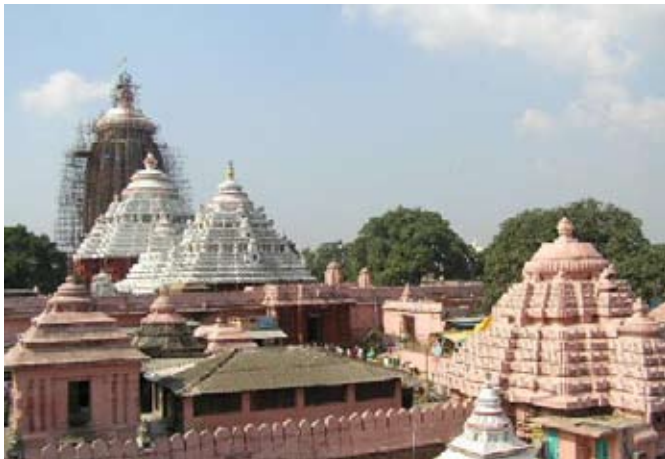
Lord Jagannath temple at Puri (Figure 1) was constructed in the first quarter of the 12th century. The monument is standing on a high platform connected with the ground level by flight of 22 steps (believed to be part of it's foundation). The height of temple is over 66 mt. It is only 2 Km away from the sea.

Fig: 1 View of temple complex

The maximum damage to the temple was caused by the rusting of these clamps. Apart from this the stone expanded due to seepage, generating pressure and causing chunks to fall.

The outer faces which was covered with lime plaster (about 45cm) had failed to control saline induced deterioration and leakage besides putting extra pressure on the fabric of the temple and hiding the beautiful carvings.

It was found that the condition of the inner walls and corbels required attention. Similarly, on the southern side of the temple major structural weakness were detected in the form of multiple cracks, missing architectural pieces, etc.

The following recommendations were made by the expert committee which was subsequently implemented through a joint venture of engineers from ASI and the State PWD (Public Works Department).

- I. Replacement of missing corbels as per the original.
- II. Replacement of rusted wrought iron cramps by stainless steel cramps.
- III. Sealing of the stone joints by a joint sealant comprising stone dust, cement, polymer (acrylic type) and non-shrink additives.

- IV. Grouting the inner core with polymer modified, flexible, non-shrink, cement grouts.
- V. Anchoring the loose cantilevers and corbel stones with help of 1.5m to 2.5m long, threaded stainless steel anchors, grouted with low viscous epoxy resins.

- VI. Providing a stainless steel anchors, grouted with low viscous epoxy resins.
- VII. Providing a stainless steel space frame, as a secondary defence to support the ground floor corbelled roof.

- VIII. Lateral confinement of the entrance corner walls of each floor by stainless steel flats.
- IX. Improvement to the existing ventilation system by drilling appropriate diameter holes through the ceiling of the first and second floor and provision of suitable ventilation duct in the top floor.

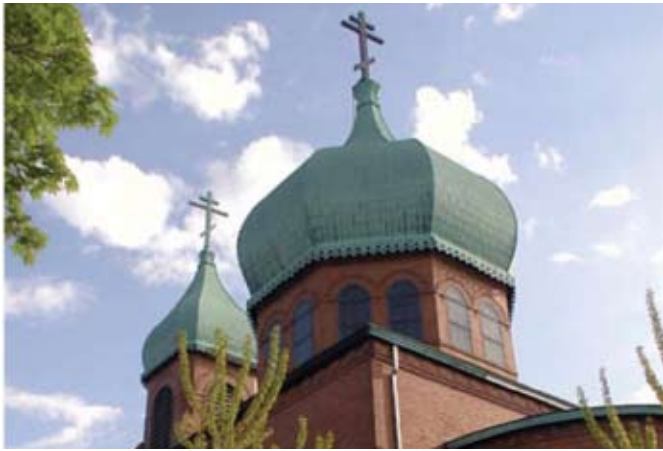
Trinity was built in 1935 and located in the East New York section of Brooklyn (Figure 1).

Fig 1: Church of Holy Trinity
