## Structural Preservation of Monument

### A Case Study Of Lord Jagannath Temple at Puri, Orissa

By N.C. Pal

(Excerpt of proceedings of All India Seminar in Rehabilitation of Structures by Institution of Engineers, Bhubaneswar in 2003 from pages 8 to 22.)

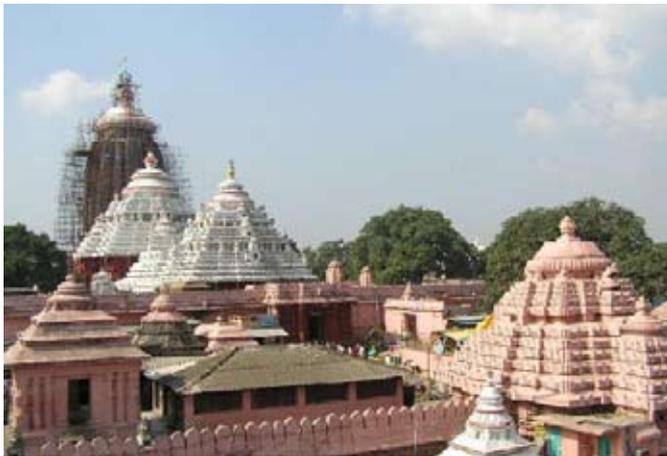
Fig: 1 View of temple complex

Lord Jagannath temple at Puri (Figure 1) was constructed in the first quarter of the 12th century. The monument is standing on a high platform connected with the ground level by flight of 22 steps (believed to be part of it's foundation). The height of temple is over 66 mt. It is only 2 Km away from the sea.
