ReBuild

Vol. 10 No. 4 (Oct - Dec 2016)

STRENGTHENING OF CONCRETE ELEMENTS Part-4

Arresting Leakages on the Inside Walls of Inspection Gallery (Muran Dam) of Upper Indravati Hydro Electric Project, Odisha - A Case Study

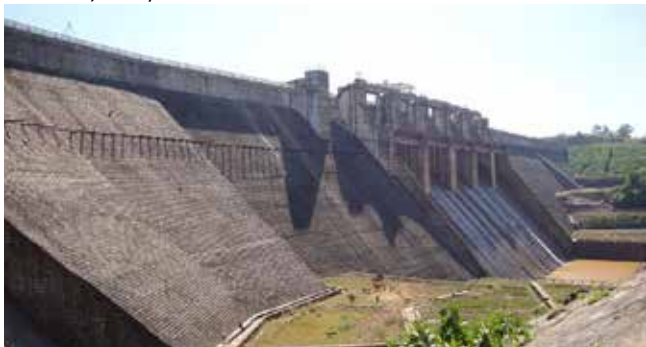
The Muran Dam is located on Muran river, a major left bank tributary of river Indravati of Upper Indravati Hydro Electric Project (UIHEP), Khatiguda, Orissa, India. This dam is a masonry gravity and concrete structure with a maximum height of 65 m and a crest length of 494 m (Fig. 1). It is provided with five spillways with a combined capacity of 8060m³ /s. It has four depletion sluices with a total capacity of 588 m³ /s.

Fig. 1: A panoramic view of Muran Dam.
