## Advanced Techniques and Instruments for Water Leakage Detection in Buildings

## Infrared Thermography for Detecting Water Leakages - Case Studies

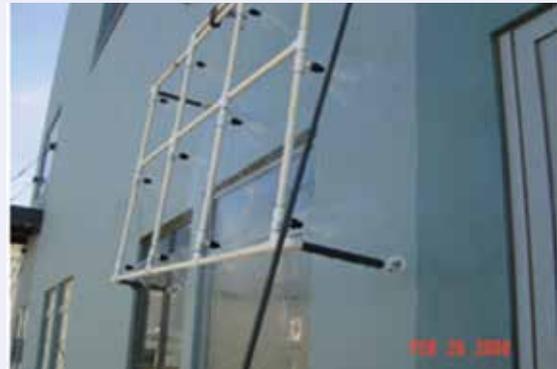
Fig. 1: A field leakage test by pipe rack system at window frame

Generally it is more convenient to use an interior mounted pressure chamber from which air is exhausted to obtain a lower pressure on the interior surface of the specimen. A calibrated rack of nozzles is then used to spray water at the proper rate on the exterior surface (Fig. 1).

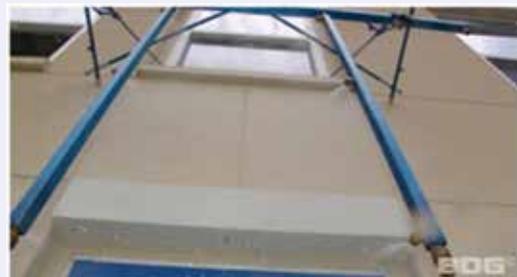
Fig. 2: Leakage test by pipe spray system at external wall

This standard describes multiple methods for determining and evaluating causes of water leakage of exterior walls. It is an investigative guide to determine if a buildings drainage capacity of the wall is causing or is likely to cause premature deterioration of a building or its contents. A field leakage test by pipe spray system at external wall is shown in Fig. 2.

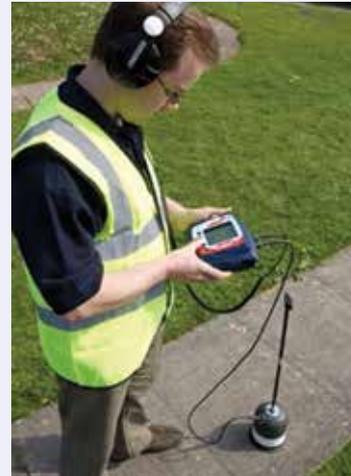
Fig. 3: Leakage detection by advanced Ground Microphones

Acoustic leak detecting instruments (Fig. 3) allow the localization of the lowest consistent noise. It offers automatic noise reduction from intermittent interfering noises, like passing vehicles, people talking, and pedestrian footsteps. This means the source of leaks can be identified a lot quicker.

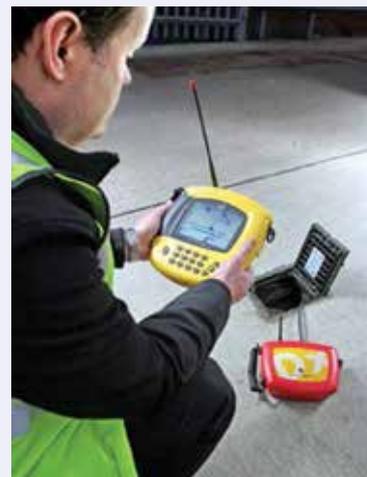
Fig. 4: Leakage detection by Digital leakage correlator

Leak correlators (Fig. 4) identify the acoustic frequency made by water escaping from a pipe. The correlator uses two sensors placed over the pipe length which detect the noise of the water escaping from the leak and calculates the leak's location by comparing the delay in the signal reaching each sensor.

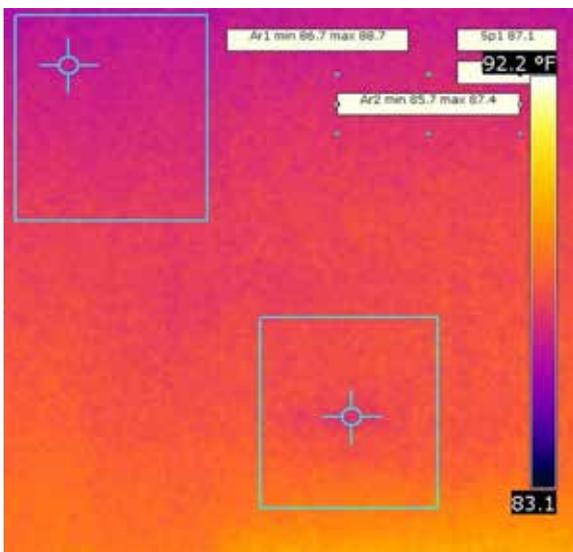
Fig. 2: From ground floor ceiling

- Dampness in the ground floor bathroom slab area coming from 1st floor bathroom (Fig. 2).
- Concealed Nahani trap (Fig. 3) and pipe line have deteriorated which need replacement.

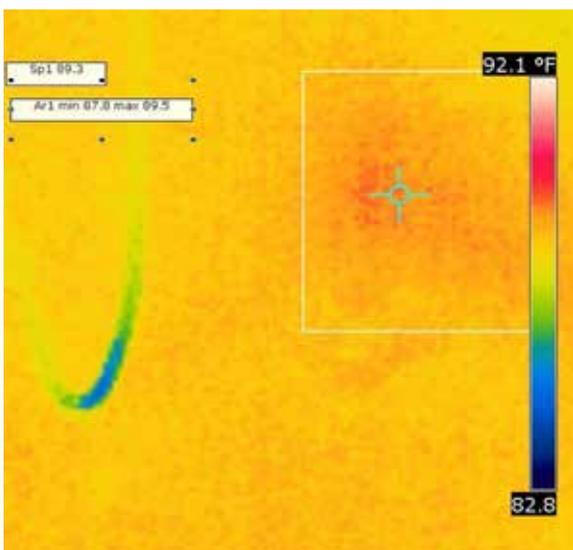
Fig. 3: 1st floor bath room near Nahani trap south wall joint

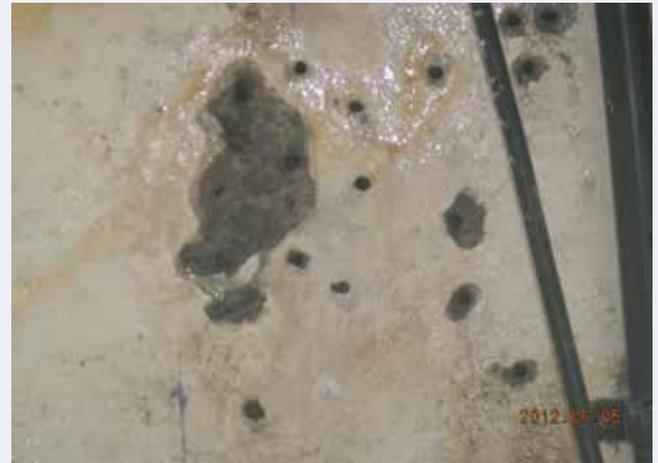
Fig. 4: Water dripping point and accumulation of water of 12th floor roof ceiling

In a 27-storey posh residential tower in south Mumbai, leakage was occurring at the 12th floor roof slab. It was observed that water was dripping from one point at continuous intervals (Fig. 4).

Some drillings were carried out on ceiling surfaces (Fig. 4) to release the water pressure. The water drop varied between 30 to 50 drops in each 10 minutes interval and increased with heavy rain but decreased without rain. The same water was being accumulated in a larger area and was dripping slowly when there was no rain. At the 13th floor, all the water spread areas such as the deck slab, water fountain, artificial water pond, back side of the fountain, were tested by visual observation, water ponding test and thermal imaging. Except for the deck slab, the other locations were ruled out as causes of the leakage. The deck slab of the 13th floor was double height of 8.4 m, without any facade protection. During the monsoons the rain water was splashing on the deck floor. Though the deck had a provision of water proofing, a leakage occurred due to a failure of the waterproofing at one transition zone of a pillar. After conducting thermal imaging, the exact location point was identified. The digital image and thermal imaging of the same spot is given in Fig. 5 & Fig. 6 respectively.

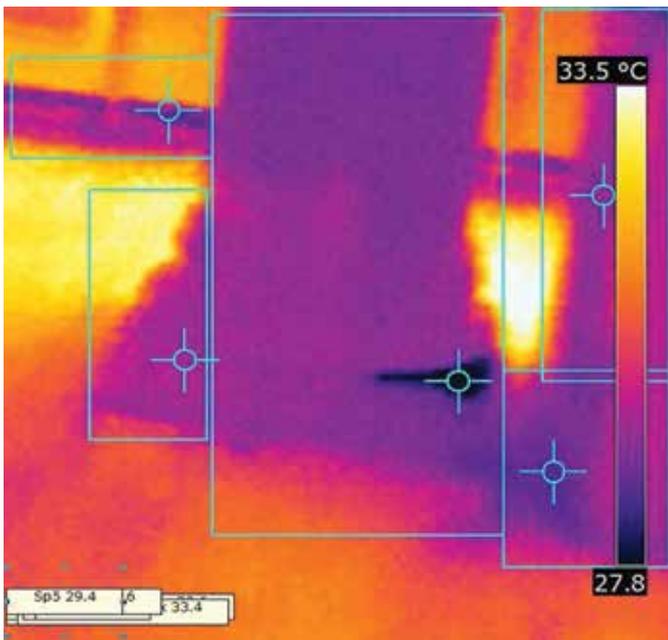
Fig. 6: Infrared thermal imaging showing gap at joints of pillar where water was penetrating

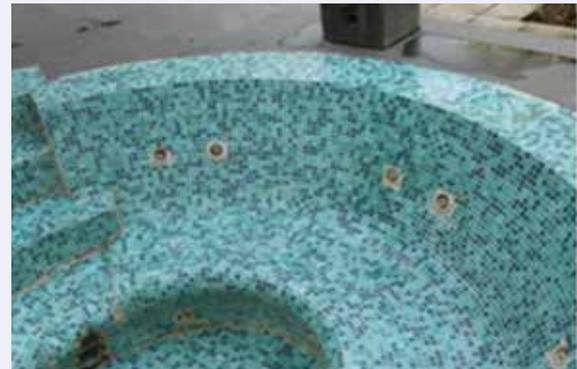
Fig. 7: Digital Image of leakage spot

A RCC framed bungalow of plinth area of 25000 sqft having all ultra modern facilities covered with lawns and landscaped gardens in Revas Road, Chondi, Alibaug had some leakage issues. It had a Jacuzzi where water leakage was occurring for which thermal imaging was carried out. After filling the Jacuzzi with full of water it was observed that the level of water was receding slowly. Wet spots were observed at few locations after making empty of Jacuzzi. There were cracks in few locations on the surface of Jacuzzi, which was identified by thermal imaging analysis. The digital and thermal images are shown in Fig. 7 to 12.

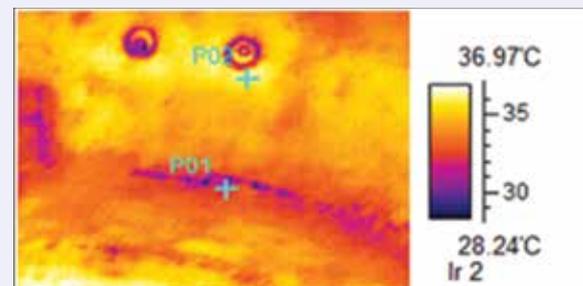
Fig. 8: Temperature :P01- 30.8°C Min.; P02- 36.4°C (Max.)

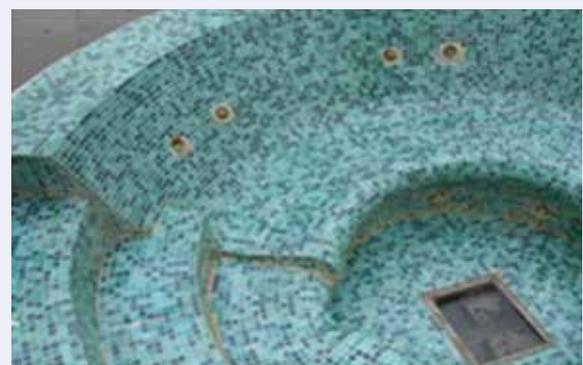
Fig. 9: Digital Image of leakage spot

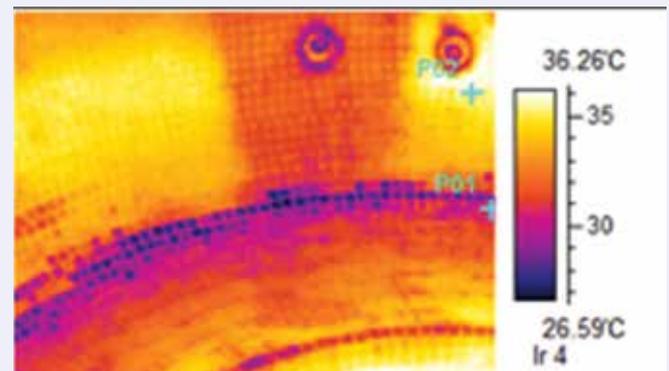
Fig. 10: Temperature : P01- 27.7°C Min.; P02- 36.1°C (Max.)

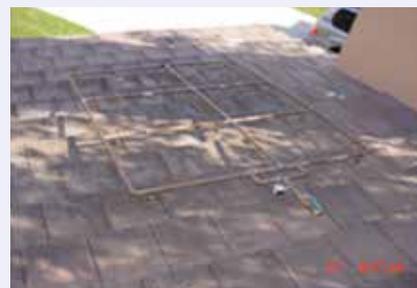
Fig. 13: Images of the spray rack system used to apply water to the roof

Water was applied to the roof from a spray rack system for 30 minutes at each location or 15 minutes using the hand held spray applicator (Fig. 13). Fig. 14 shows the positions of the rack system for each 30-minute test. Entire roof surface was divided into number of panels for the spray followed by thermal imaging at ceiling surface of the same location and testing was conducted in each panel. Soon after the spray rack system was moved into another position, water intrusion was found in the ceiling of the residence. During this test no water intrusion was found, indicating no water intrusion points for this area of the roof.

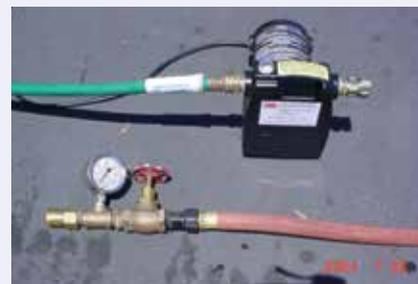
Fig. 14: Image of the hand held applicator and its position during the water test of the gutter area as well as the positioning of the spray rack system
